Technical Paper

Actual Damages at Compressors- Failure Mechanisms and their Root Causes

**Dr. Persigehl, Bernhard
Allianz Risk Consulting GmbH
Allianz Center for Technology (AZT)
81724 Munich –Germany**

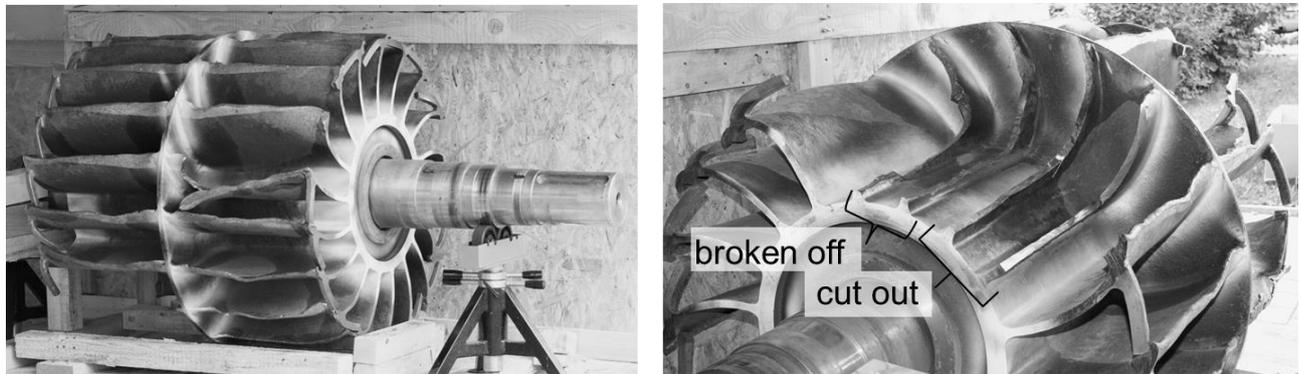
Fig 1: Damaged liquid ring compressor

All blades were heavily deformed. Two blades were completely broken off, the two adjacent blades almost. From these two, the residual of the blades was cut for laboratory analyses of the manufacturer. The derived root cause was a foreign object damage.

In order to prove or disprove this theory, the debris found within the compressor casing were examined using X-Ray fluorescence analysis (RFA). The material composition of all debris was nearly identical. However, a foreign object damage could still have been the root cause, theoretically: either the foreign object completely disappeared during the damage event or the foreign object consisted of the same material than the rotor. But, the likeliness for one of these theories is limited.

Therefore, it must be assumed, that these manufacturing defects led to a weakening and thus to an overloading of the compressor airfoils. Based on these results, the compressor was damaged due to a manufacturing fault, not by a foreign object.

In order to prevent a similar damage in the future, a better quality control of the rotor after the casting, e.g. by ultrasonic testing, should be executed. Cast defects exceeding specific limits must be detected before installation and operation.

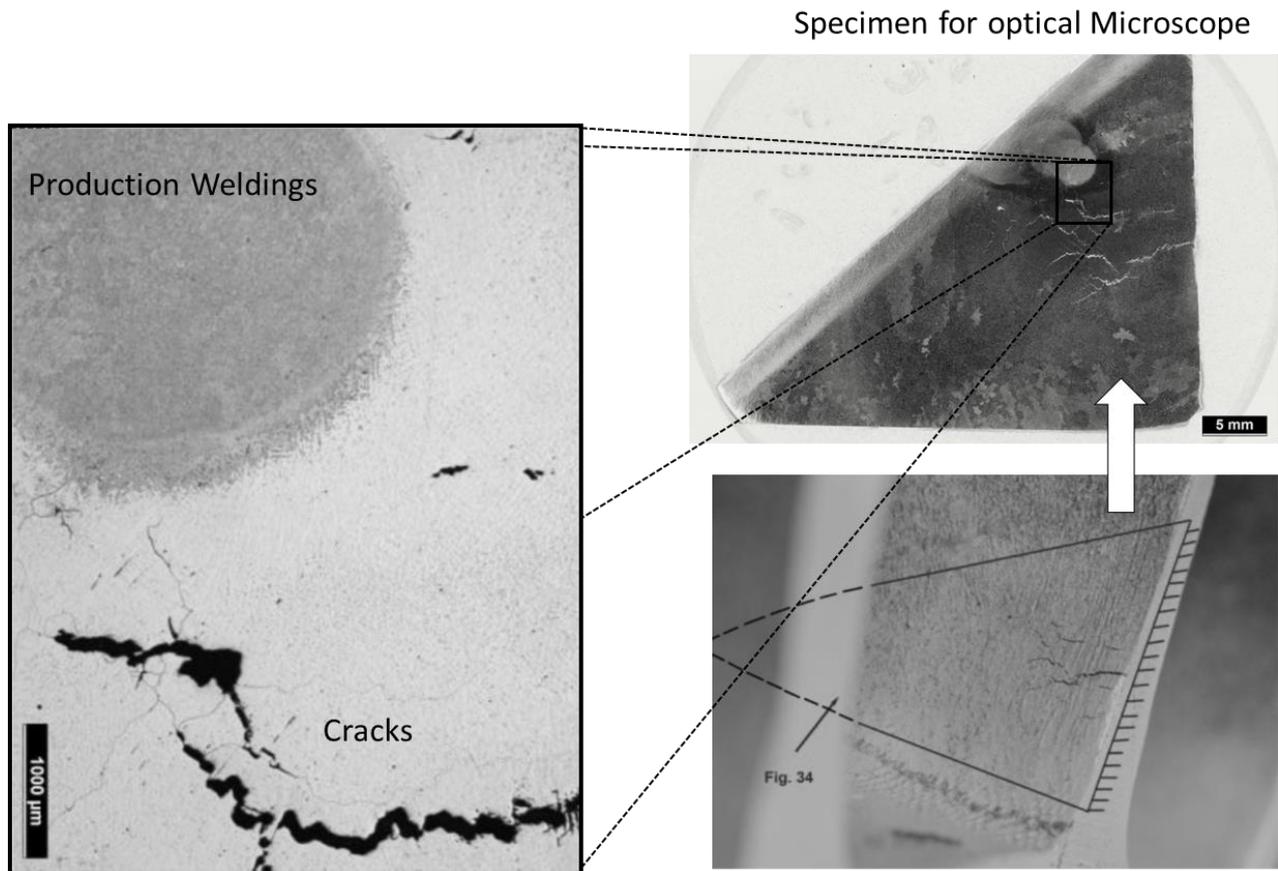
Therefore, a crack detection test was conducted to find some possible original cracks. i.e. cracks that were obviously not due to a secondary failure. Here, numerous cracks could be identified. Several specimens at different positions at the rotor were cut out, see one specimen in Fig. 2: These specimens were investigated in the optical microscope.

Within the specimens a multitude of casting defects (hot cracks and welding defects from repair welding) were found. From these defects cracks were initiated.

Fig 2: Production Welding and Cracks within specimen

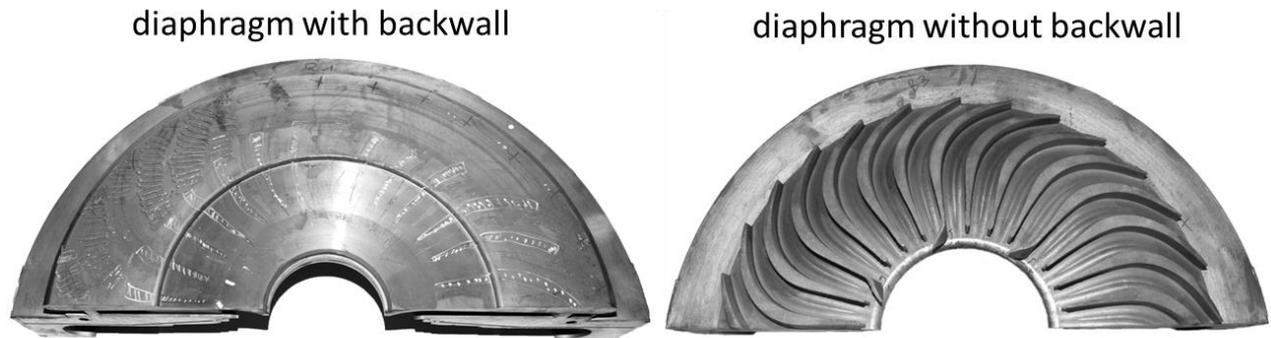
The compressor consists of seven centrifugal stages. In some diaphragms the backwall was detached from the profiles. During manufacturing the backwalls are joint with the diaphragms via high temperature brazement, compare a diaphragm with or without backwall in Fig 3:

Fig 3: Overview of the investigation parts from the multistage circumferential compressor

Since it is common understanding that brittle phases at the center line of brazed joints are to be limited and since the amount of center line cracks are high within the investigated backwalls (about 75%), the quality of the brazements has to be questioned.

Whether the center line cracks were already existent before commissioning or developed during operation, could not be clarified. Since the compressor was operated over a period of 8 years without failure, a “poor” brazement quality can not be the only factor for these crackings. Besides, no signs for stepwise propagation could be found. Therefore, the detachment was probably triggered by an overloading event (e.g. by the reported shock wave).

To ensure the integrity of brazements after manufacturing the diaphragms should have been tested via ultrasonic tests after the brazing process, as it was done by AZT at the beginning of the laboratory investigations. In Fig 3 left, regions with poor metallurgic joint between backwall and profile are marked in white.

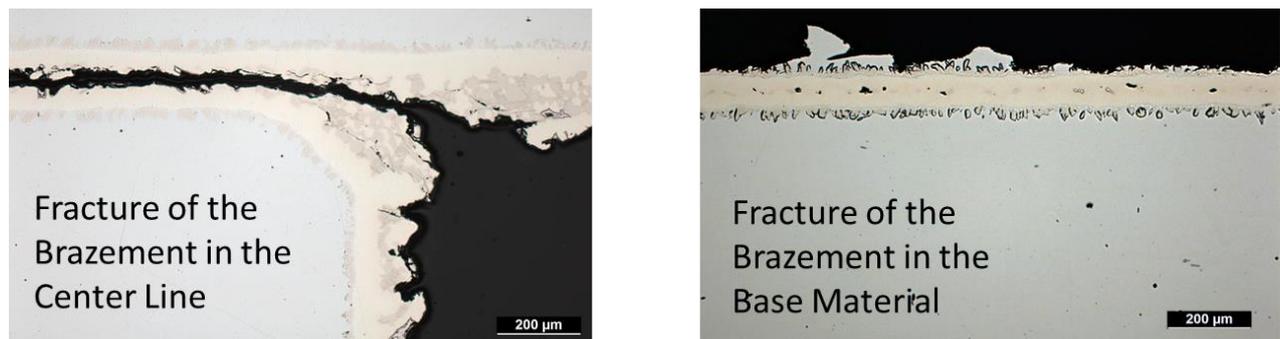
Different brazed joints were analyzed by scanning electron microscopy (SEM) and optical microscopy with respect to the integrity of the brazements and the fracture surfaces of original and forced joint fractures. Two different fracture modes were identified: Forced fracture either occurred within the diffusion zone of the brazing material into the base material (right side in Fig 4) or within the center line of the brazed joints, along chains of brittle phases (left side in Fig. 4).

Fig 4: Comparison of the fracture surfaces within the optical microscope

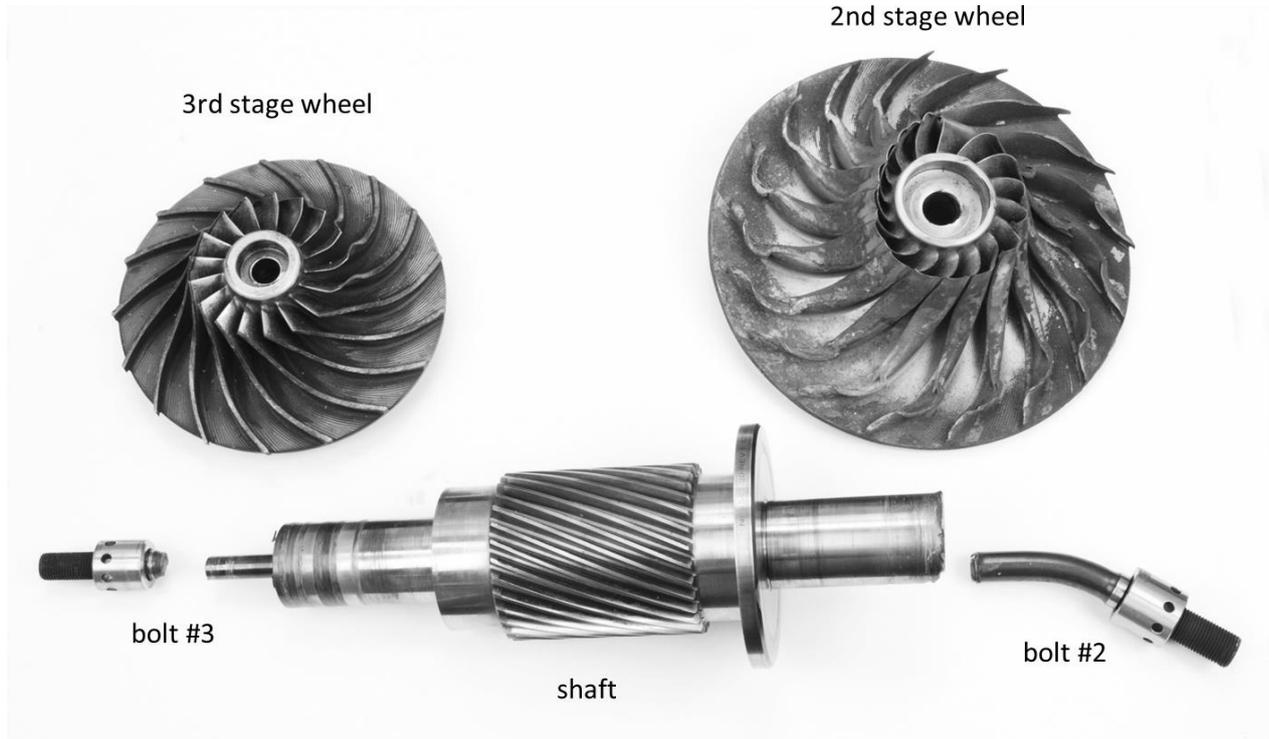
wheels was heavily damaged, see Fig. 5. Both bolts to fix the rotor wheels on the shaft were broken.

Fig 5: Overview of the investigation parts from the geared compressor

Based on the macroscopic findings it is very likely that the bolt at rotor #3 broke first. Due to the resulting unbalance of the shaft and the missing axial force of compressor wheel #3, a rubbing of rotor #2 versus the casing could be initiated. Thus, bolt #2 was overloaded, bent and broke. From AZT point of view, no scenario is imaginable why bolt #3 should have failed as secondary damage after a theoretical failure of bolt #2, since no hard rubbing marks were found at rotor #3. Thus, there is no reason for a secondary failure of bolt #3.

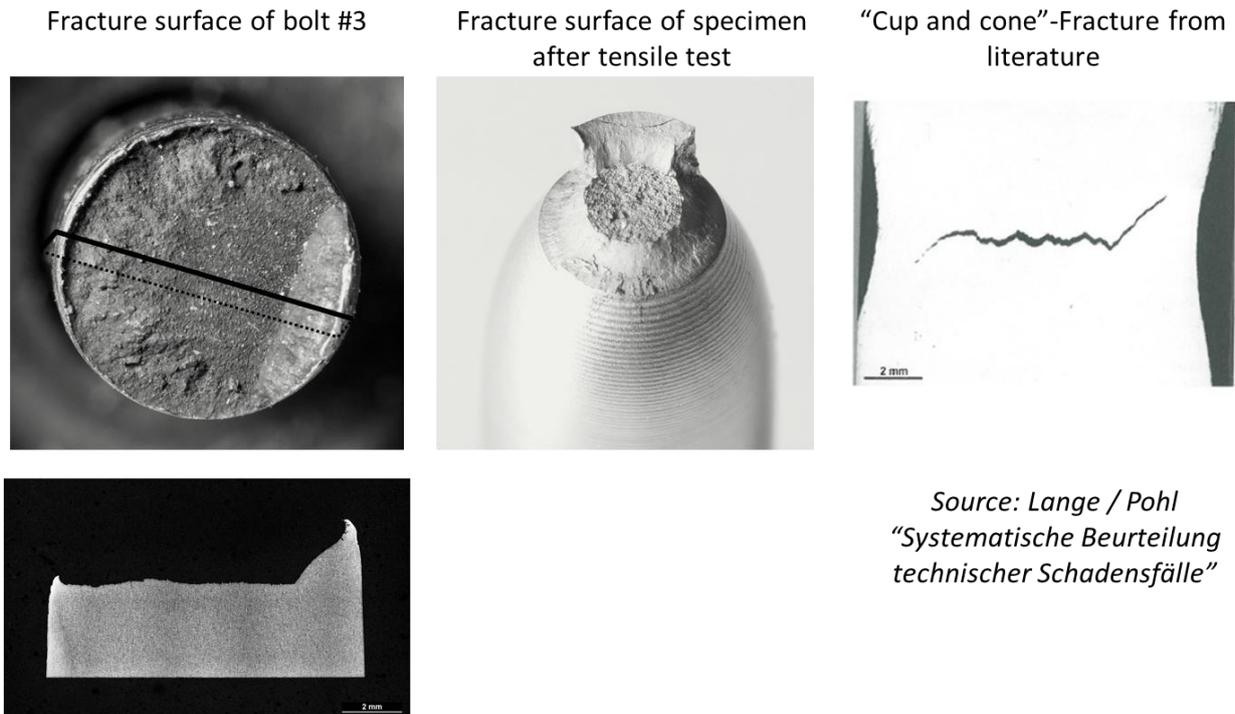
The fracture surfaces of both broken bolts #2 and #3 were investigated using a SEM and an optical microscope. Neither bolt #2, nor bolt #3 failed due to a fatigue fracture. The causal bolt #3 broke due to a forced fracture. The fracture mode is a “cup and cone” fracture. The fracture pattern of the conducted tensile test (with a specimen cut out of the undamaged part of one bolt) was the proof that the specified material cracked as “cup and cone” fracture, see Fig. 6:

Fig 6: Comparison of fracture surfaces

This fracture mode is typical for axial overloading. Different causes were discussed for this overloading event. As most likely cause a malfunction of the compressor blow off valve behind stage #3 was identified. Due to such an opening the back pressure of the compressor would suddenly drop down to zero, resulting in an axial force on compressor wheel #3. However, a direct proof for this theory could not be found, since the amount of operational data (as the position of the mentioned blow off valve) was limited.

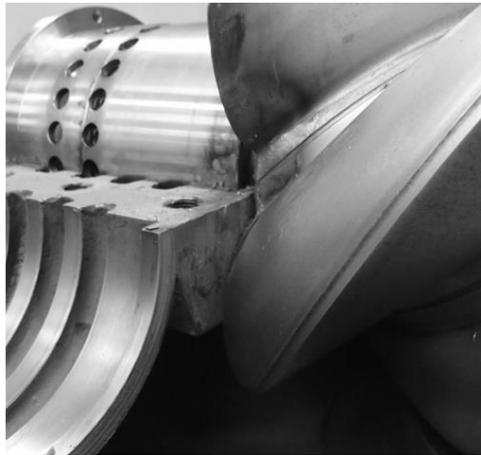
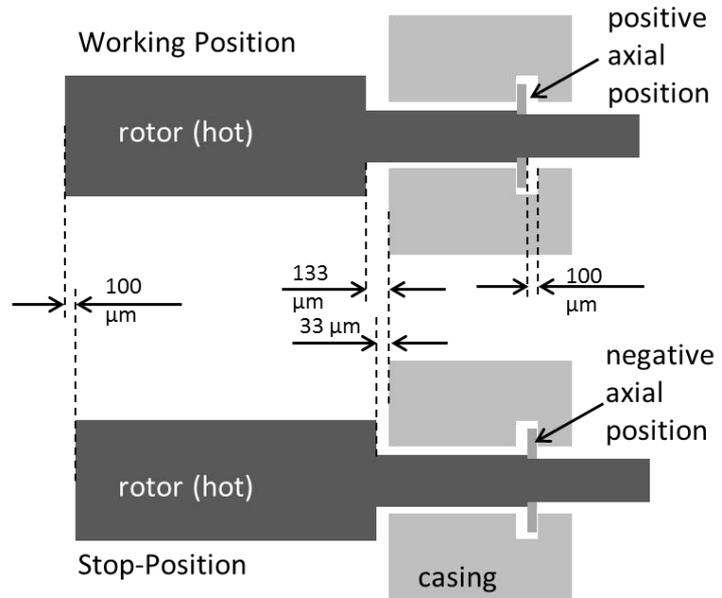
At the end, a damaged screw compressor is shown from an air supply for a test facility. Both rotors rubbed axially against the casing, see in Fig. 7, left hand side. On the front side of the rotors the annealing colors can be seen from the rubbing event. One rotor could only be disassembled with high forces, since the connection between rotor and casing resembled a cold welding.

damage. In all of these imaginable operating situations a remaining axial gap of at least $33\mu\text{m}$ between the rotors and the casing remained, see an example in Fig. 7, right hand side.

compressor after disassembly of the „female“ rotor

Fig. 7: Damaged screw compressor (left) with annealing colors, different axial rotor positions (right)

The root cause has been approximated on a rather theoretical basis, as follows: A foreign particle entered the axial clearance between the (cold) rotor and the casing during the last start-up of the machine. During this start-up, the pressure difference between inlet and discharge side was low. Besides, the rotational speed was still low. Thus, the flow forces and the centrifugal forces on the foreign particle were limited enabling generally the ingress of the foreign particle into the axial gap.

As remedial action an air filter with a smaller mesh size was installed at the facility as well as a recording of the operating data including an automatic control of operations.
