LESSONS LEARNED FROM DAMAGES OF MECHANICAL DRIVE TRAINS OF WIND TURBINES

Allianz Risk Consulting GmbH
Allianz Zentrum für Technik
Dr. Thomas Griggel/ Thomas Gellermann

24 May 2019, Dresden

VGB Workshop
MATERIALS AND QUALITY ASSURANCE

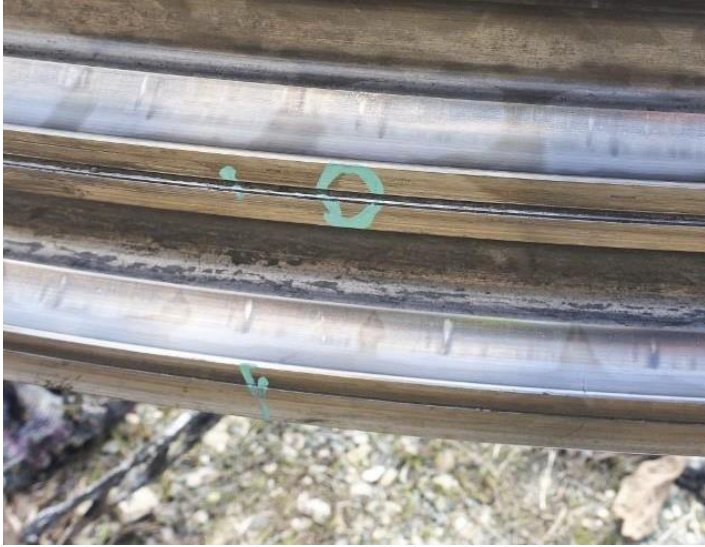
False Brinelling

Main contributors

- (Long) standstill periods of the bearing under dynamic loading
- Lubrication

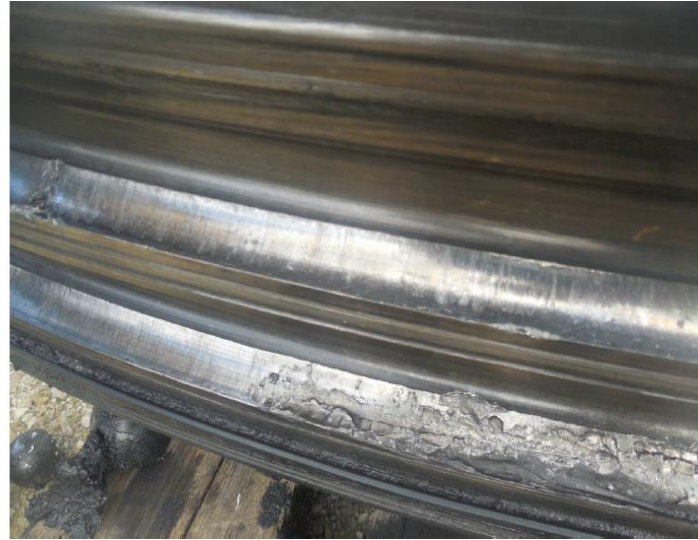
Local spalling to the outer edge of the raceway

Main contributors

- High operational loads
- Cage design

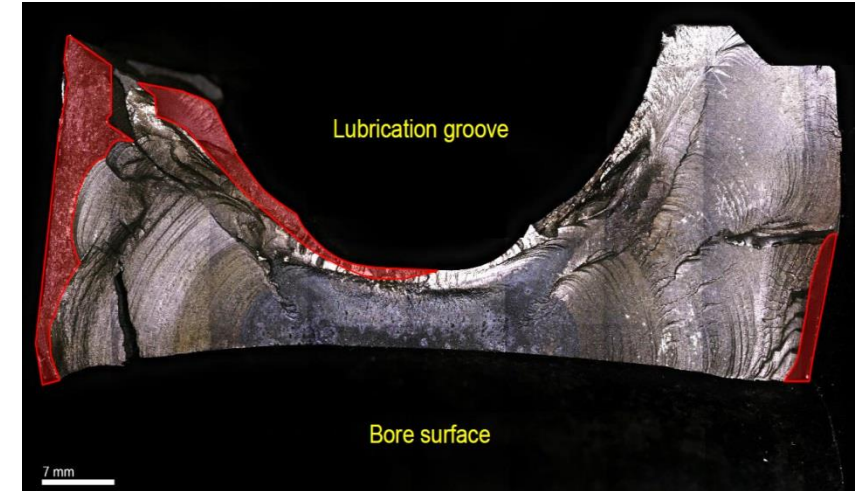
Stress corrosion cracking developed from bore surface

Main contributors

- Corrosion
- High static and dynamic loads

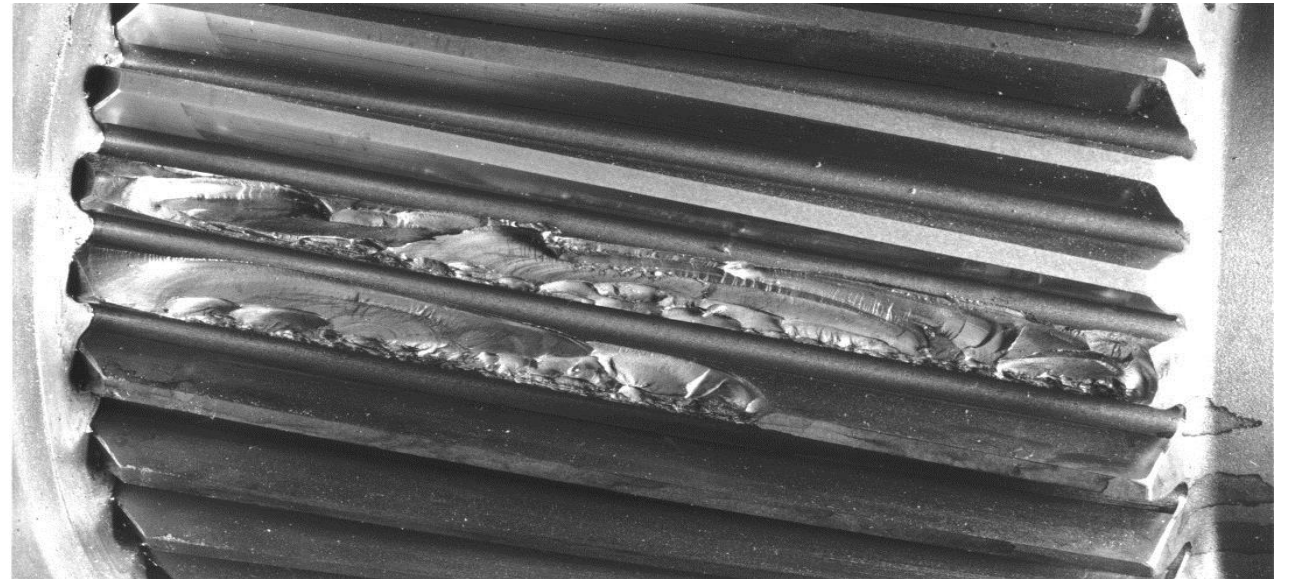
Failure mode Flank Breakage

- known from turbogears used for gas / steam / water turbines for a long time
- crack start (CS) beneath hardening zone (HZ) from non-metallic inclusions
- fatigue crack growing under flank surface until breakage
- exchange and repair of gearbox

HZ = hardness zone

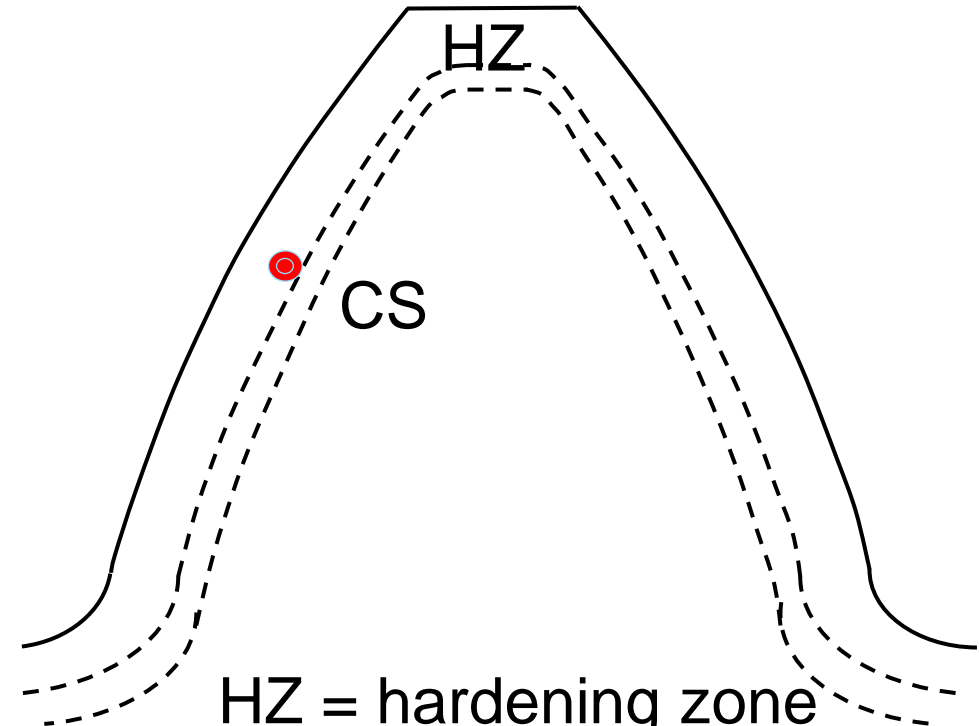
Contributors

- Sufficient case hardening depth
 - Sufficient material quality (NMIs)
 - Very high loads
 - Check gears design acc. to new ISO/TS 6336-4:2019-01
- To be ordered by customer!**
- Tooth volume test

HZ = hardening zone
CS = Crack starter
HD = hardening depth
NMI = non-metallic inclusion

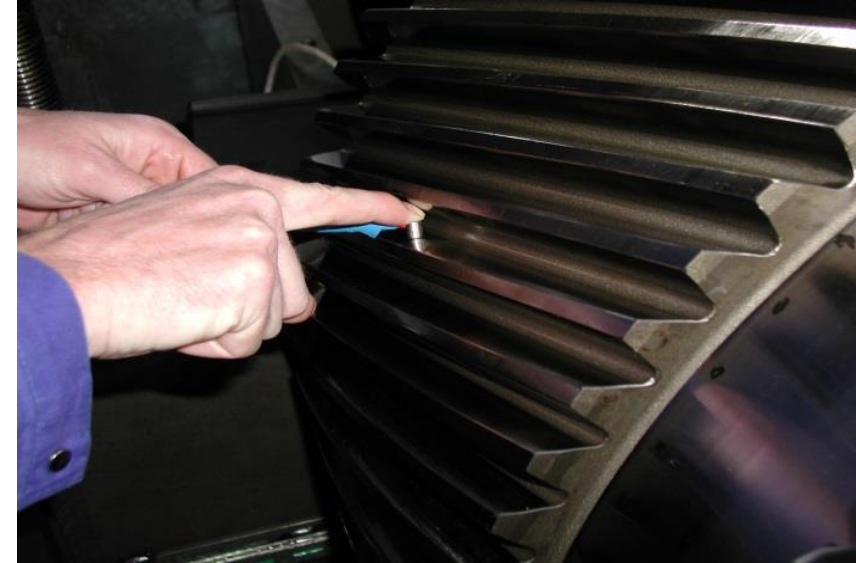
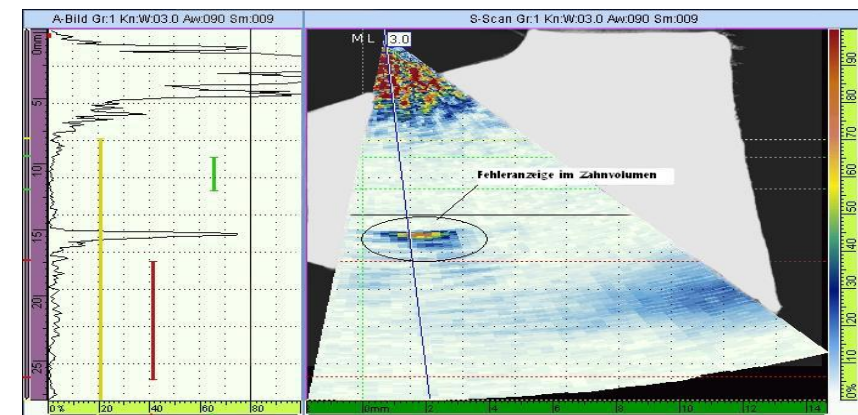
AZT tooth volume testing based on ultrasonic testing

- Detection of critical cracks in the tooth volume
- Crack development detectable by repeated testing
- Problem: direct access to gears is needed!
- Recommendation: Tooth volume test for prototype or during repair

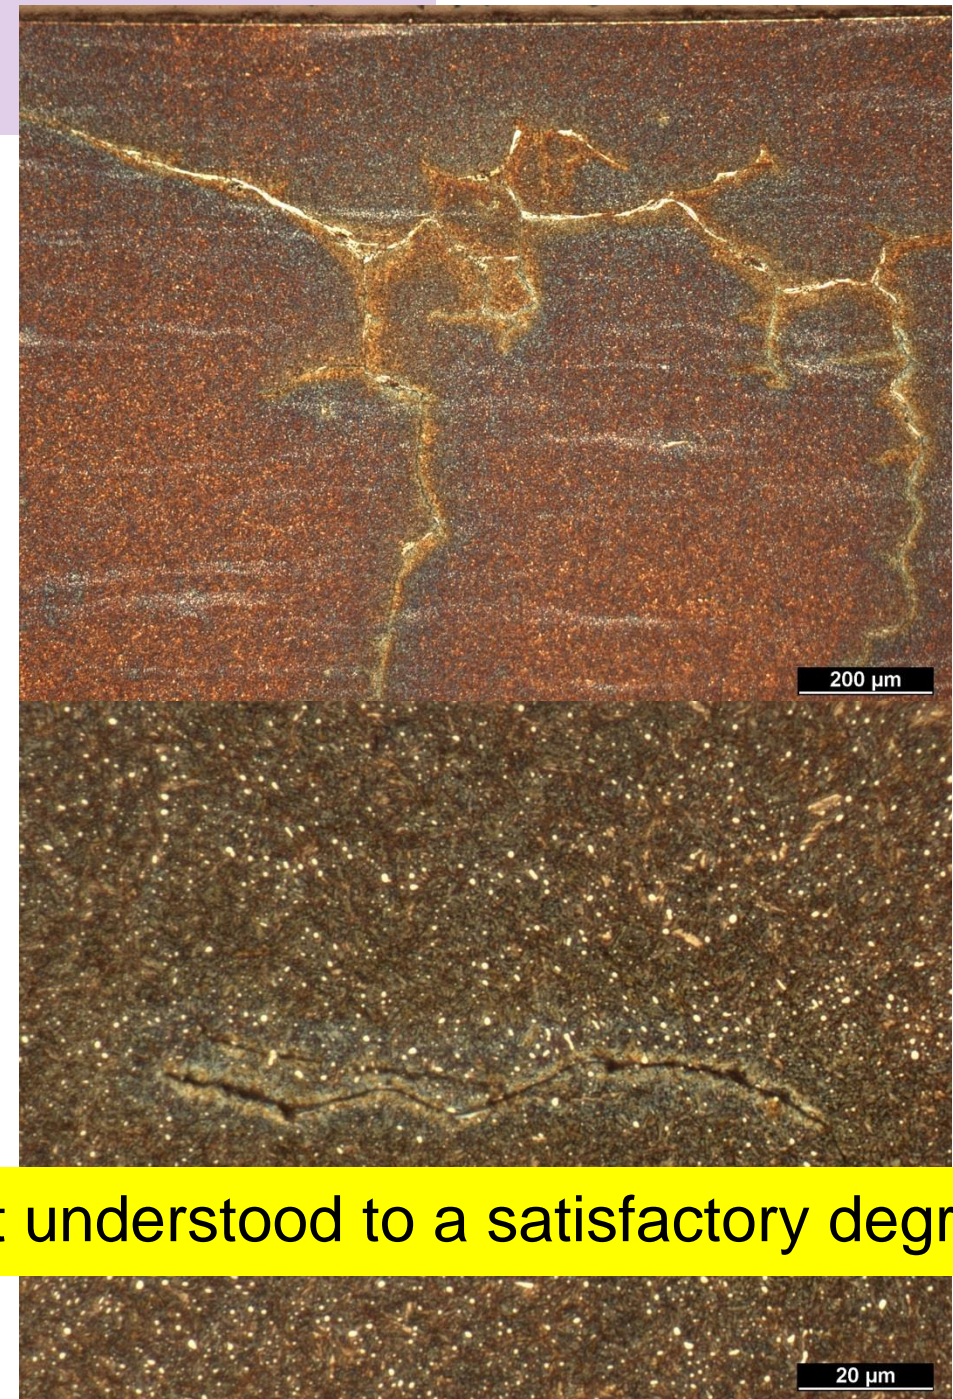
Failure Mode WEC

- Cracks and White Etching Areas (non-etching) in specimens of roller bearings after 5-10 % of rated lifetime
- Different damage mechanisms
- Possible contributors
 - Lubricant (additives)
 - Hydrogen
 - Electrical current
 - Slippage
 - Bearing material
 - Finishing
 - Vibrations
 - ...

WEC is a complex failure mode, which is not understood to a satisfactory degree!

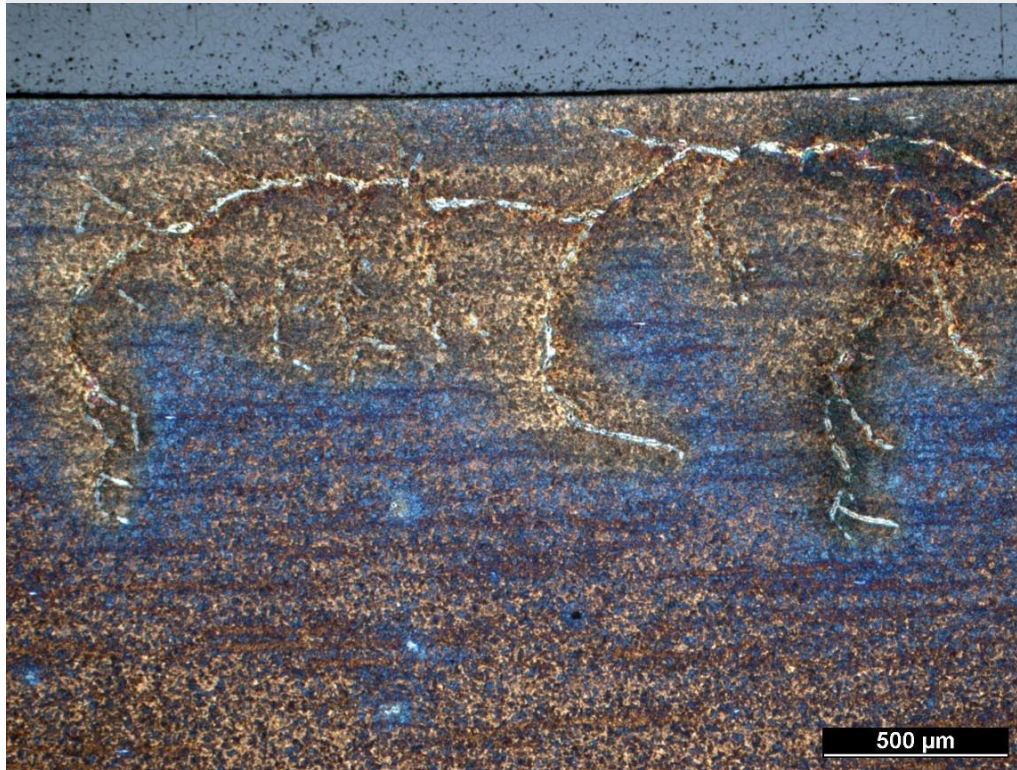
Generator bearing – electric current

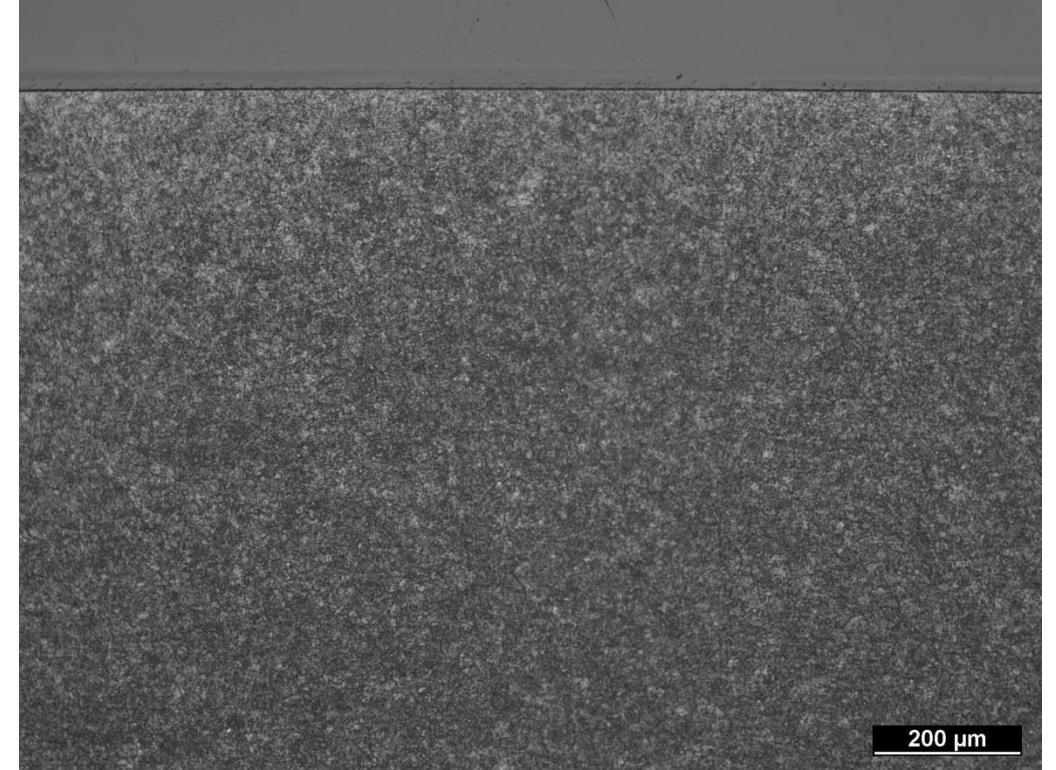
Pump bearing – electric current
