# DAMAGE EXPERIENCE IN SOLAR THERMAL POWER PLANTS

Dr. Bernhard Persigehl  
Dresden / May 24<sup>th</sup>, 2019

Allianz Risk Consulting GmbH – Allianz Zentrum für Technik

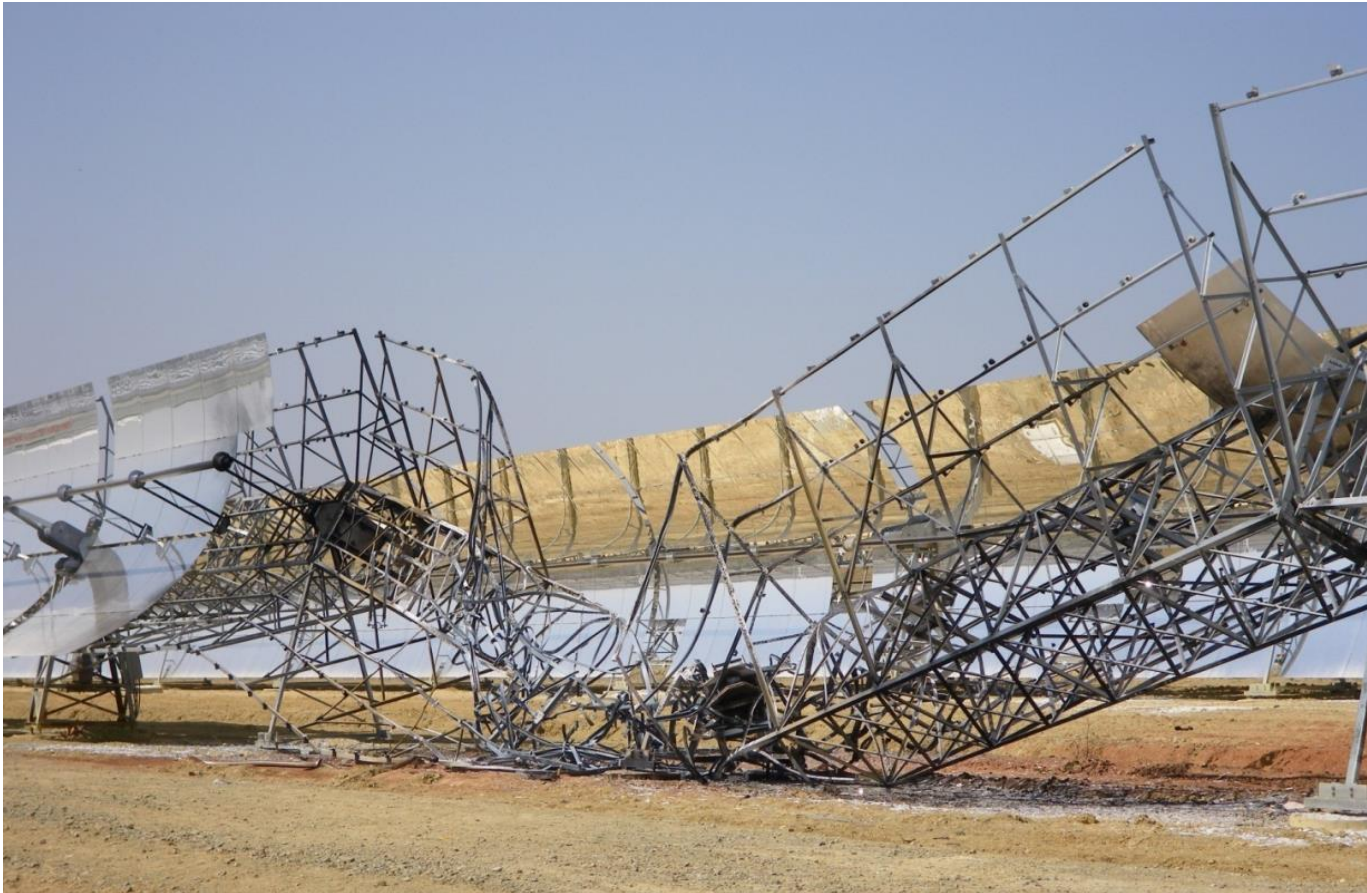
Damage due to:  
Welding Error during Assembly

Small leakage lead to Ignition of Heat Transfer Fluid (HTF, thermal oil)

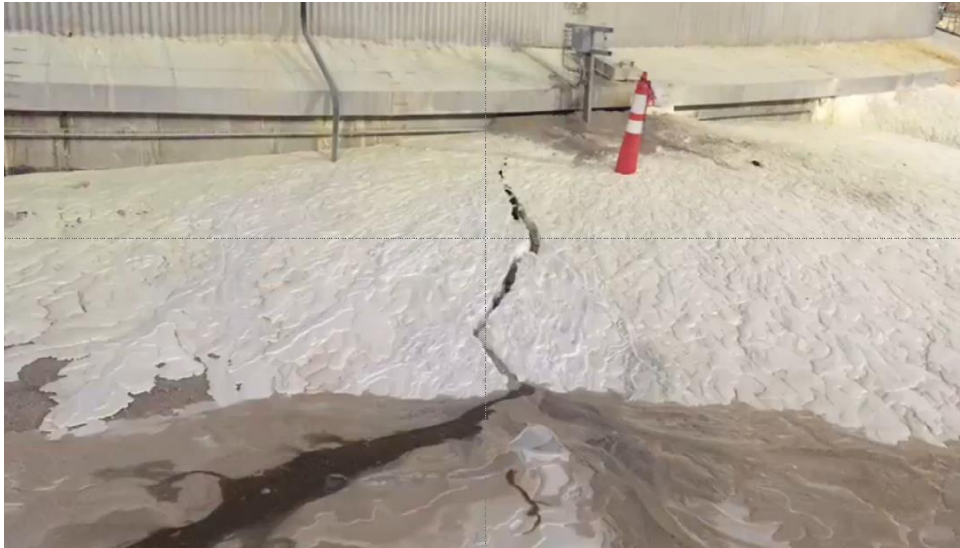
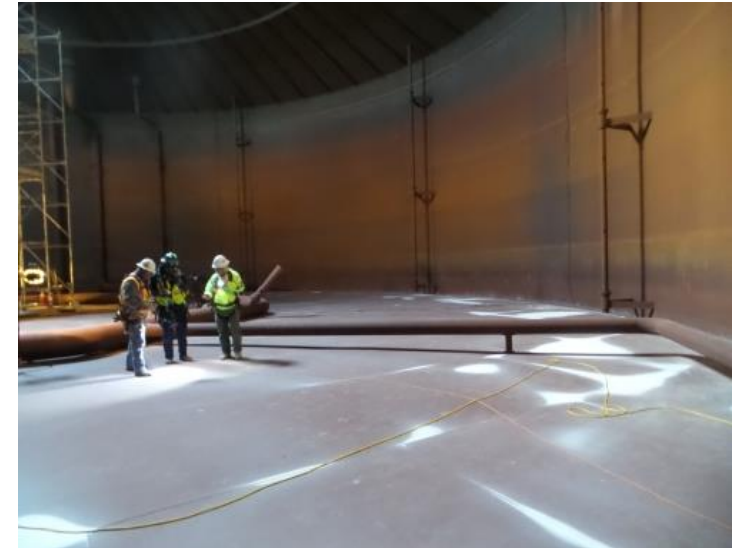
- Cold salt immediately crystallizes
- Tank only accessible from the top
- Tank has to be completely drained
- 6 month standstill

- The salt inlet pipes were welded to the tank.
- Overdetermined
  - No degree of freedom for thermal growth
  - Crack initiation to the tank

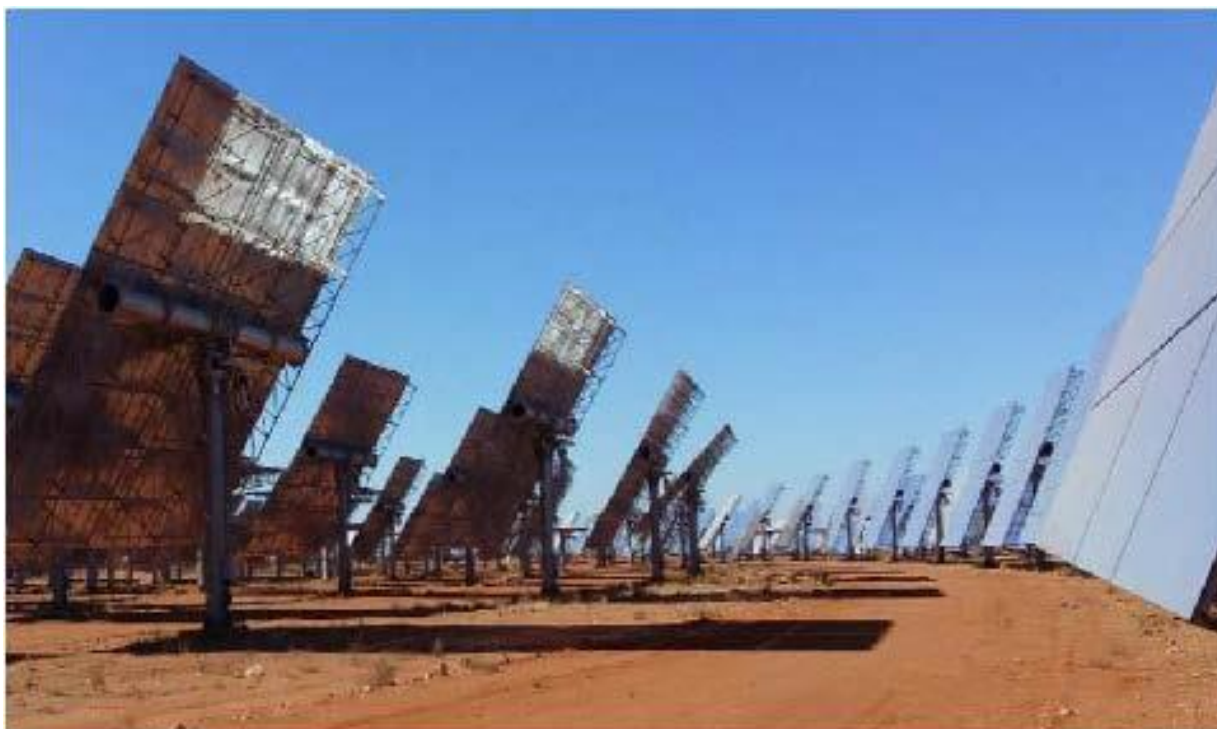
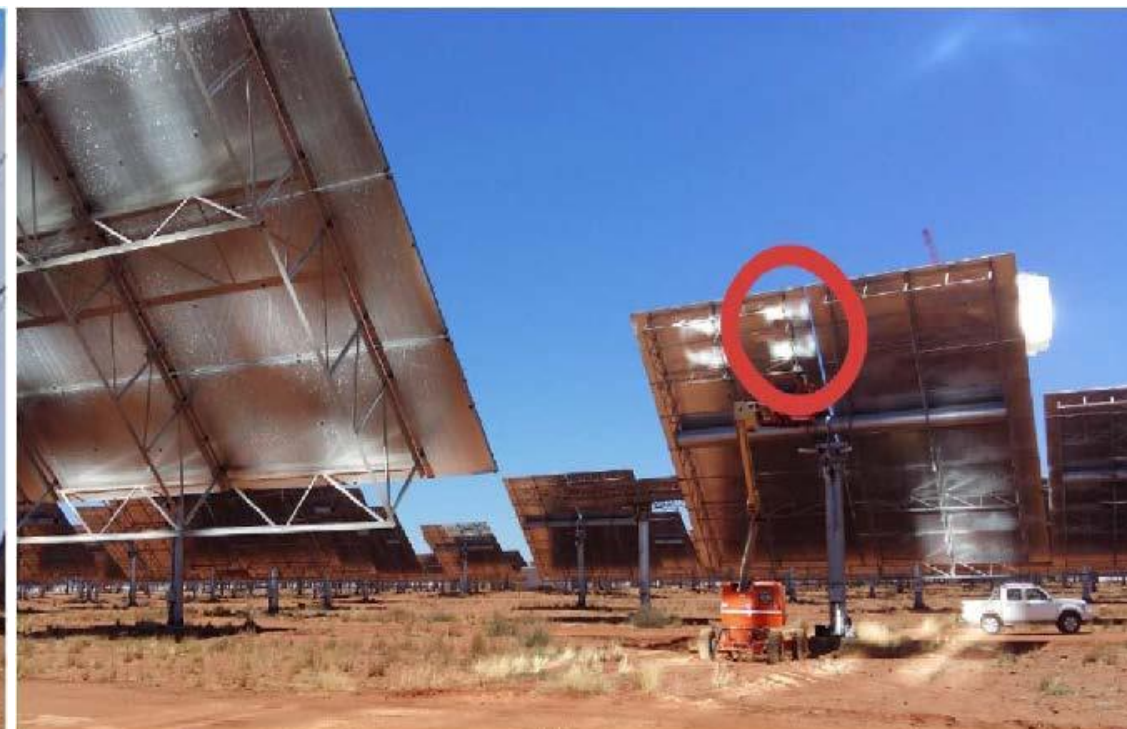
## 1. DOUBLE BLOCKING

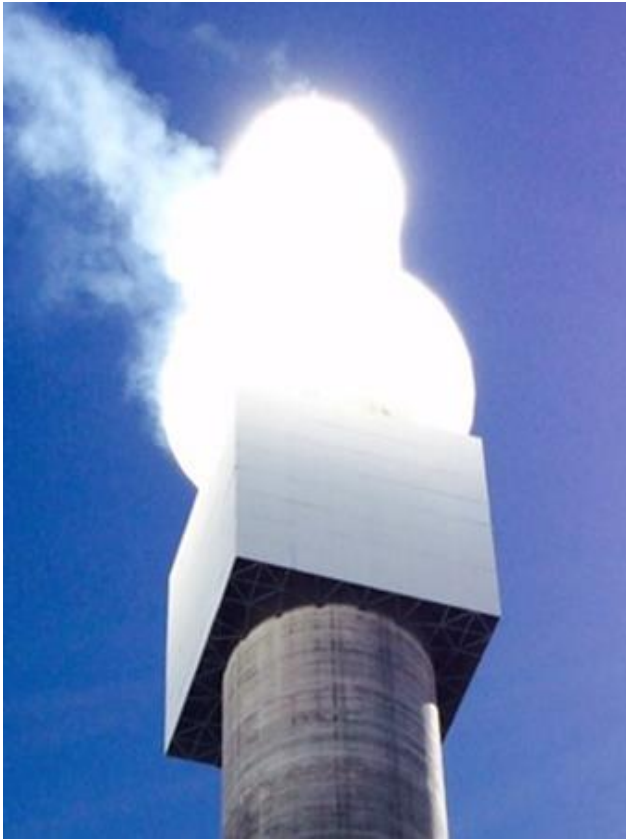
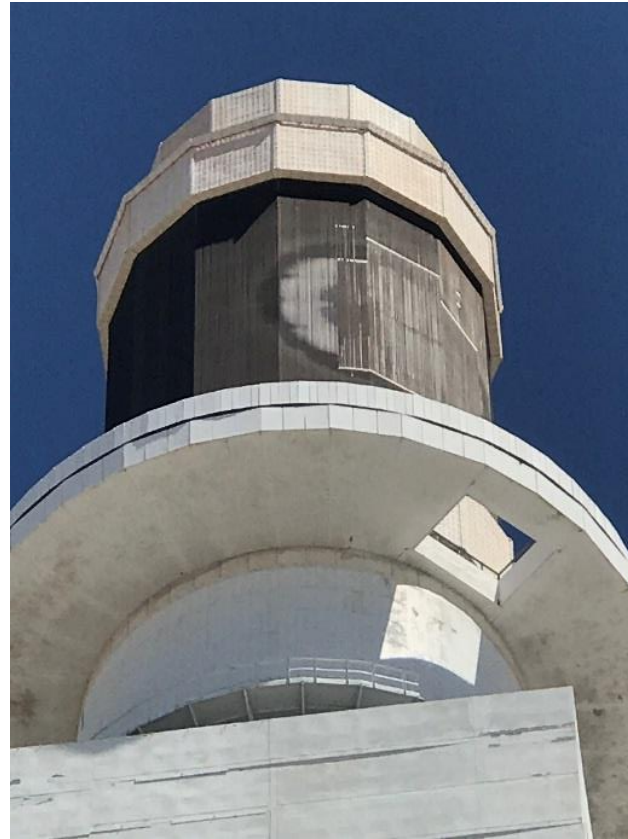
- Too many heliostats concentrated at one point → energy density too high
- Heliostats are aligned before HTF is flowing through receiver

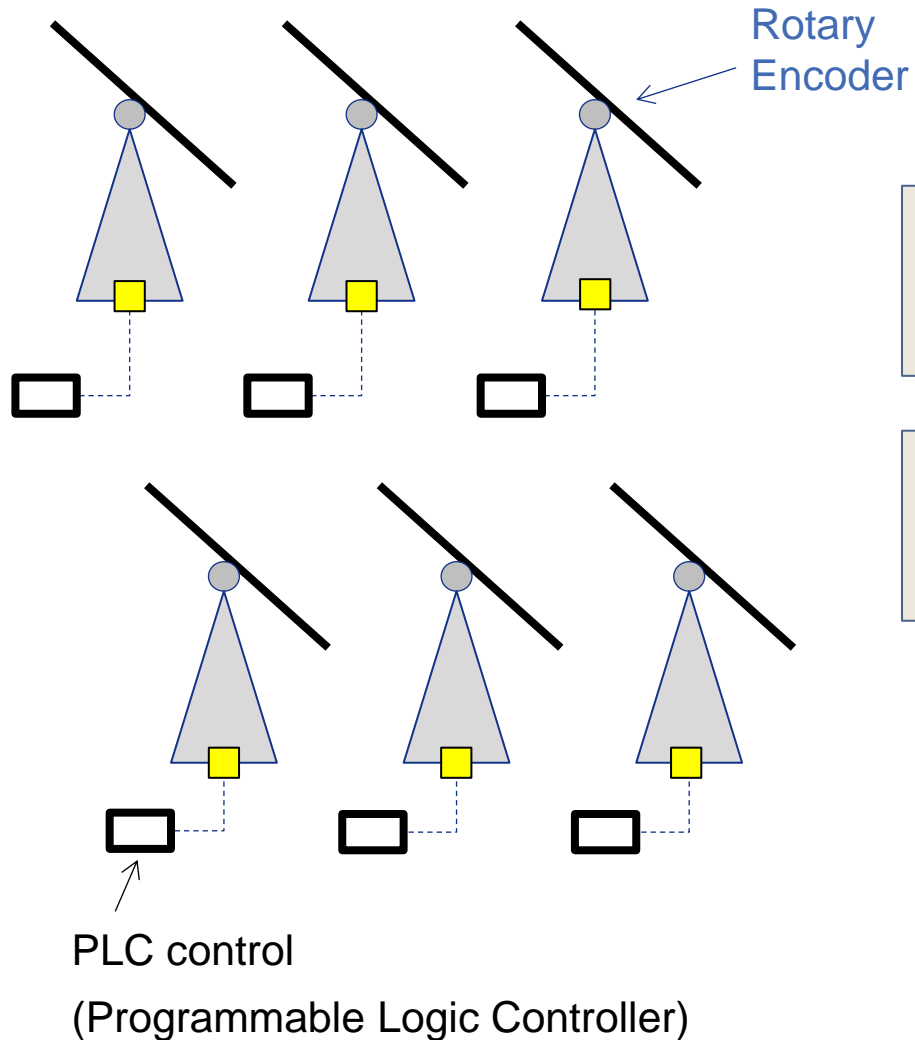
The rotating position of several heliostats could not be controlled as requested.

An inappropriate firmware within the encoders led to interruption of the communication between the encoders and the PLCs during start-up.

- Change of all encoders → very expensive
- New PLCs → risky
- Implementation of an additional relay in front of each encoder to avoid the communication problem

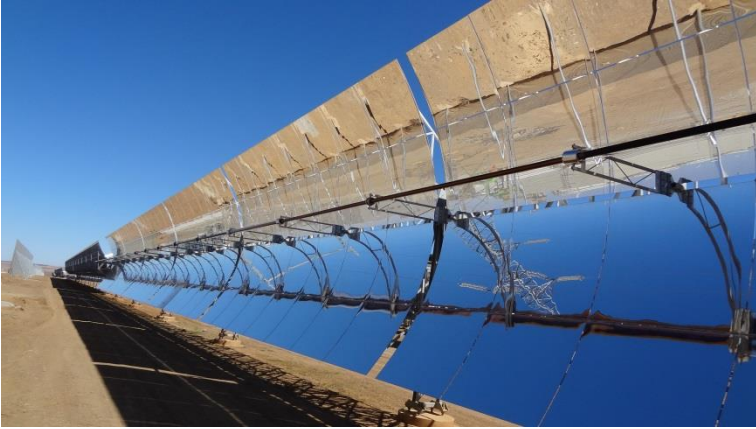
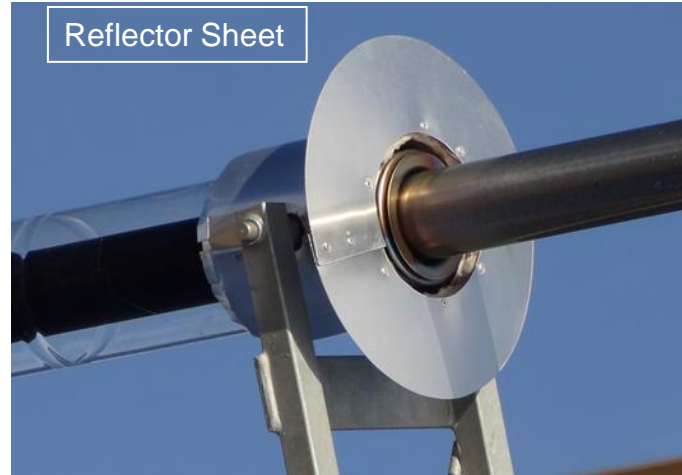
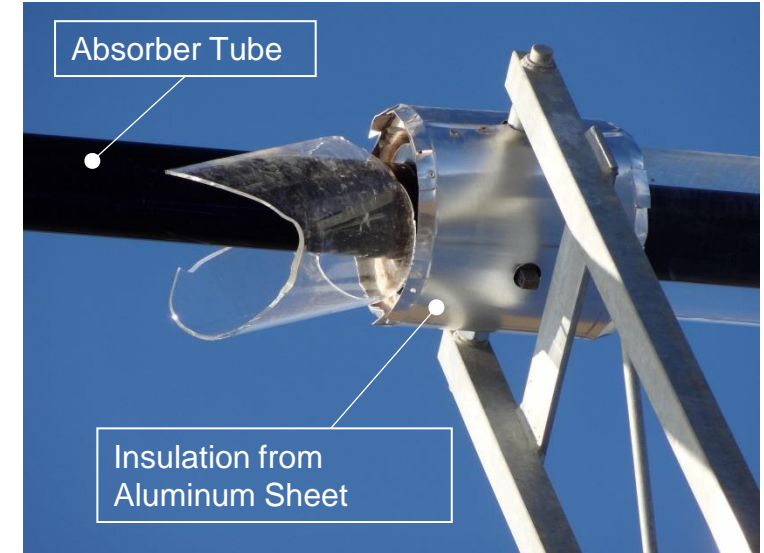
2.500/22.000 cracked glass tubes shortly after commissioning.

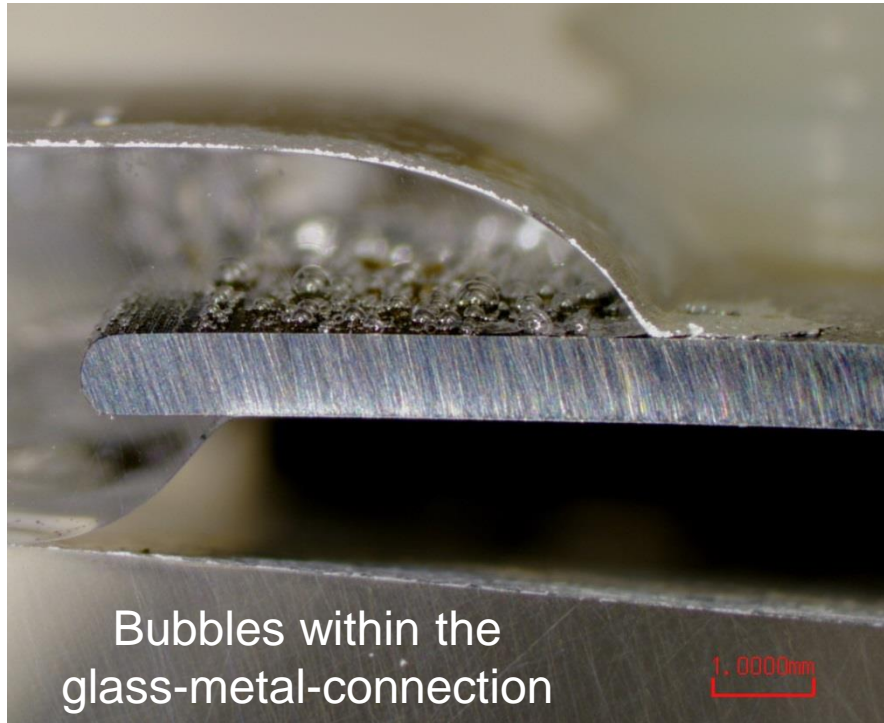
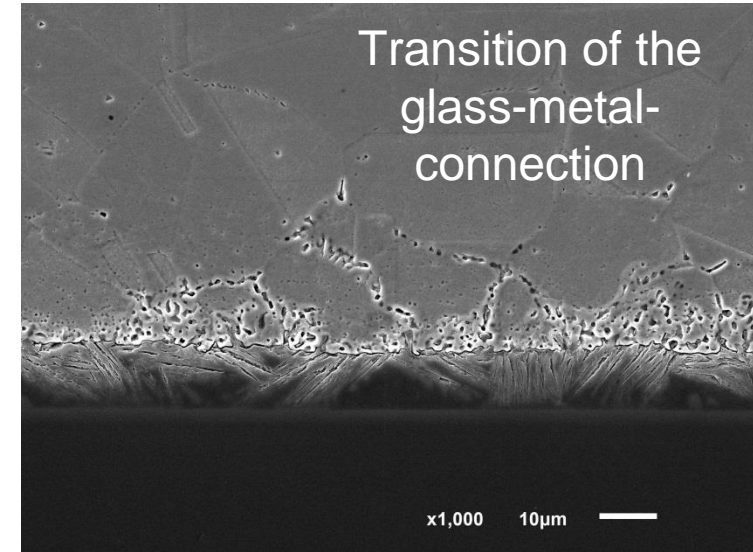
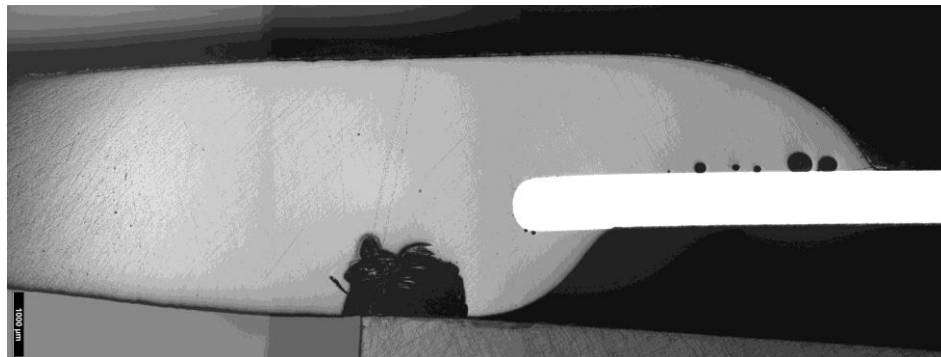
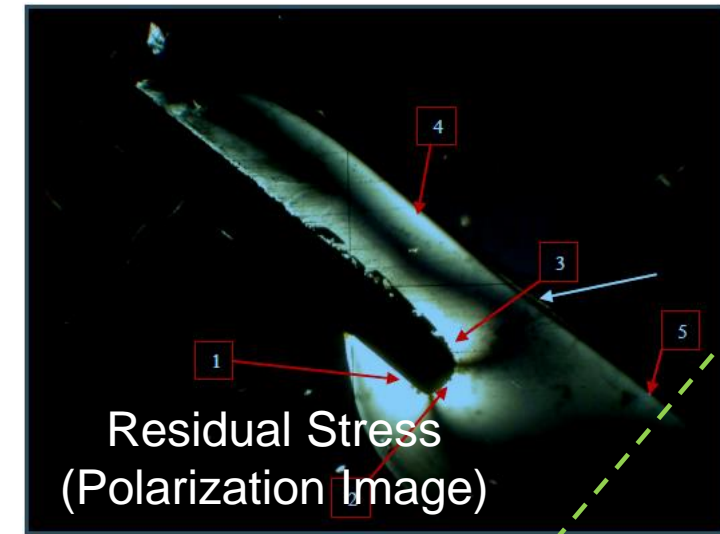
The found defects are not the cause of the damage!

Fracture Level

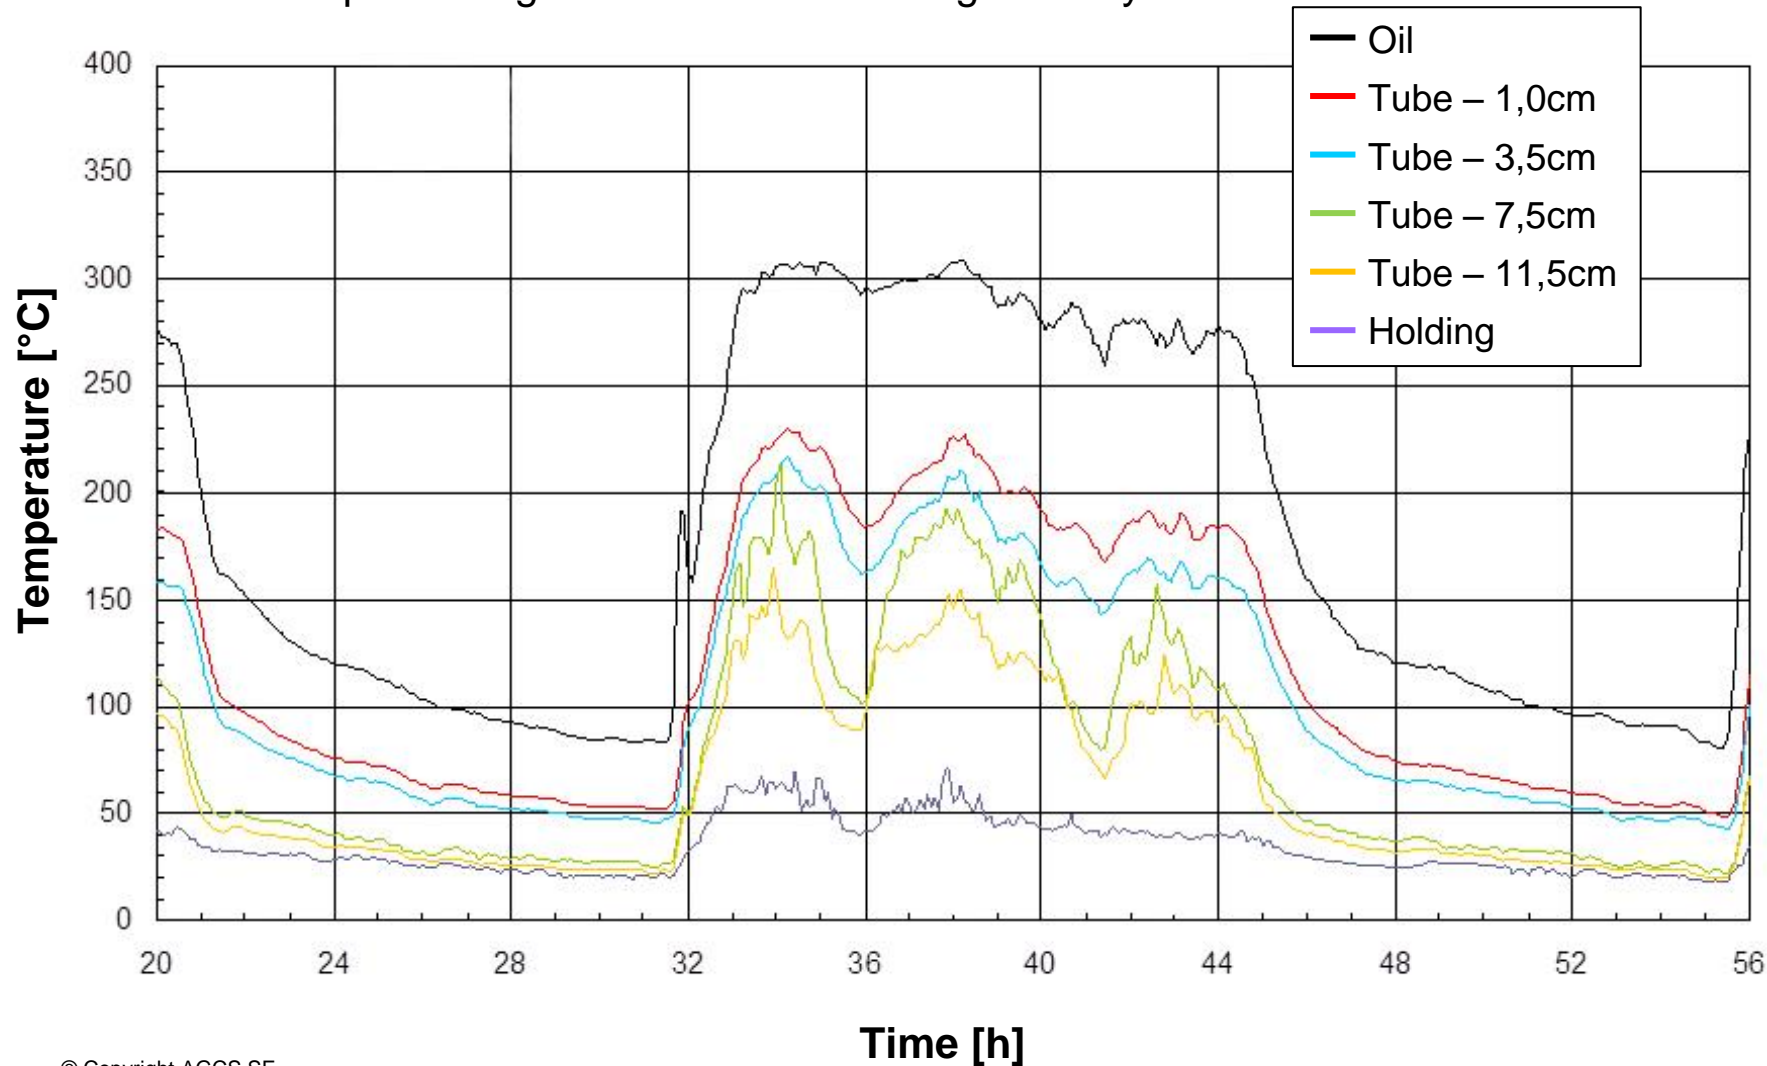
Measured temperature gradients of 200K during one day

FEM calculation showed that the resulting high stresses are not critical for intact glass tubes.

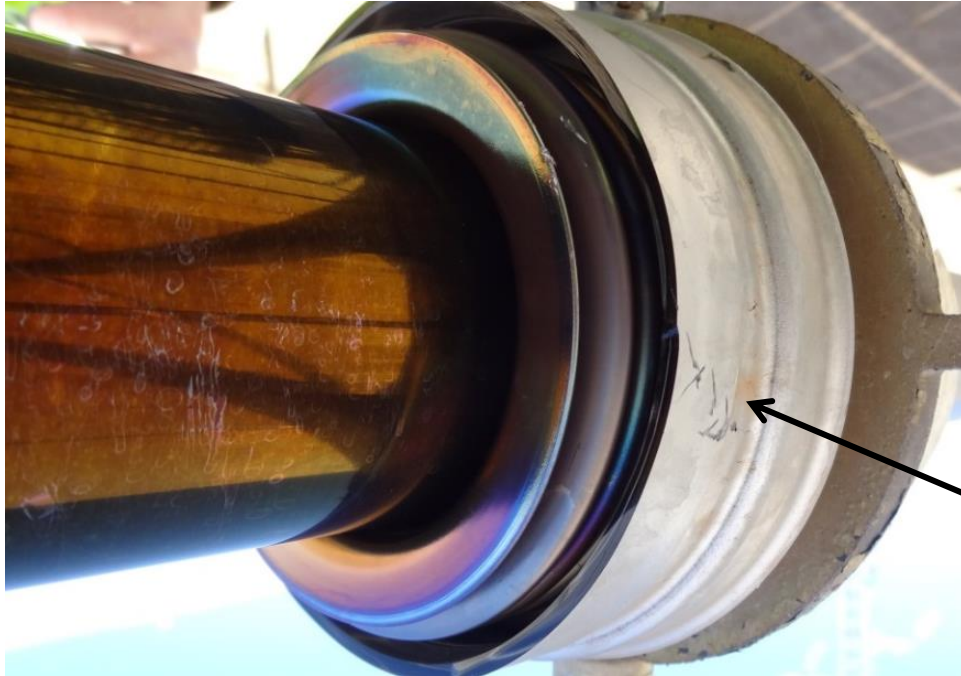
Scratch

During the installation of the receiver tubes the glass surface was scratched onsite during the assembly of the metal insulation.

Due to the high thermal loads during start and stops the scratched tubes broke.

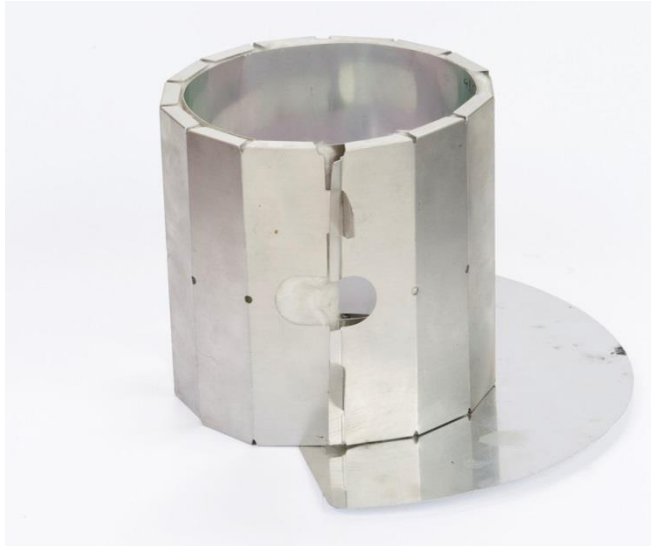
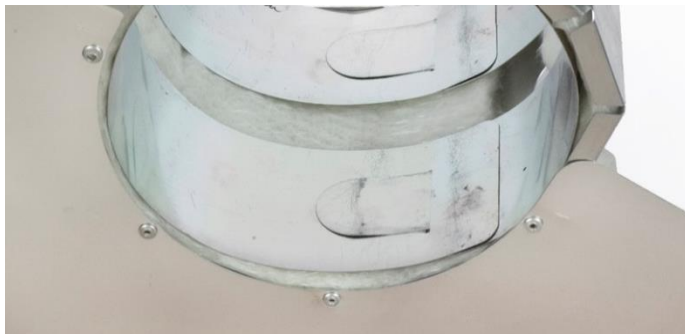
Original design

No sharp edges, no boreholes, plug-in connection

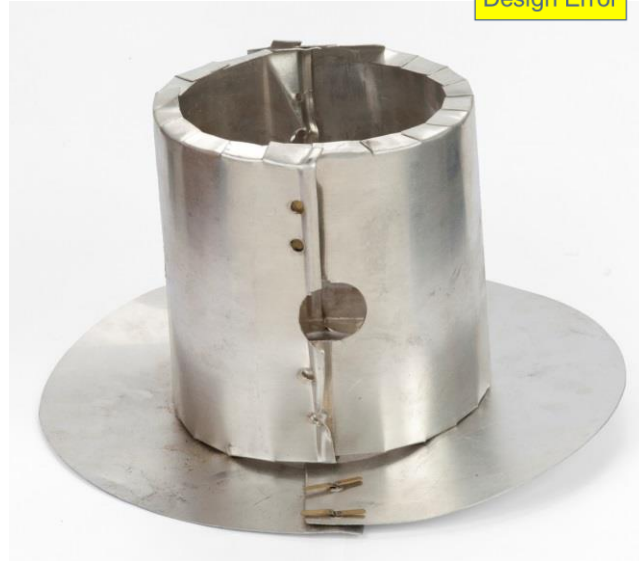
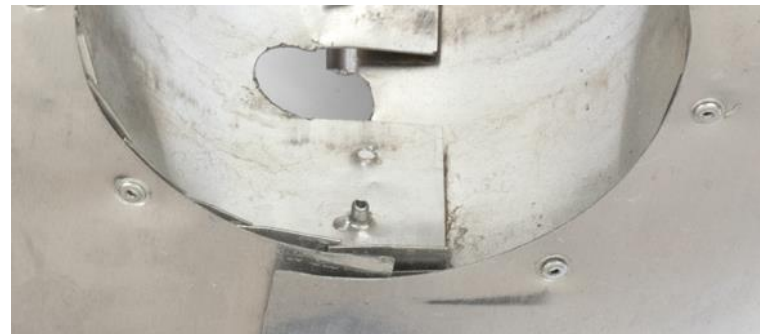
Design of a local sub-contractor

Many sharp edges, boreholes for the rivet connection

Local sourcing from inexperienced sub-supplier can cause critical quality issues.

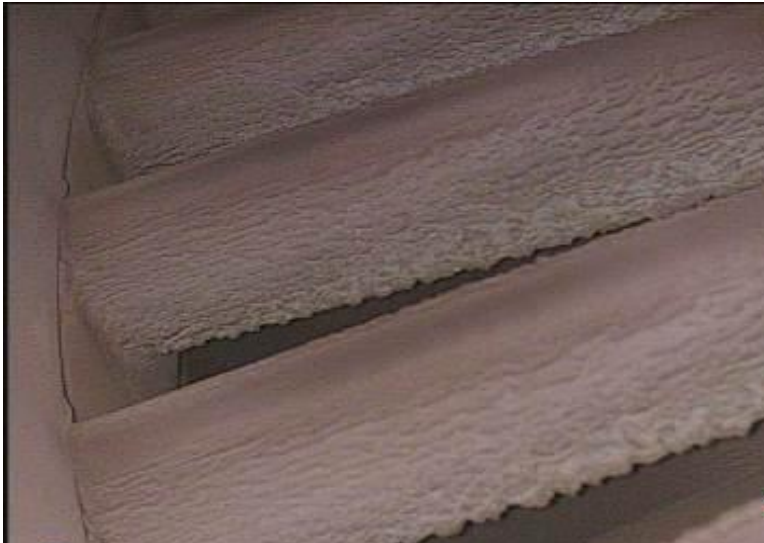
→ Borescope inspection revealed deposits in few stages in the middle of the steam turbine.

Stage with deposits

→ Analysis of the deposits showed mainly Aluminum

Residuals of Aluminum stayed in the system. They agglomerated in the affected stages, since the arising temperature of 300°C fits to a level change of the aluminum oxide.

→ Design Issue

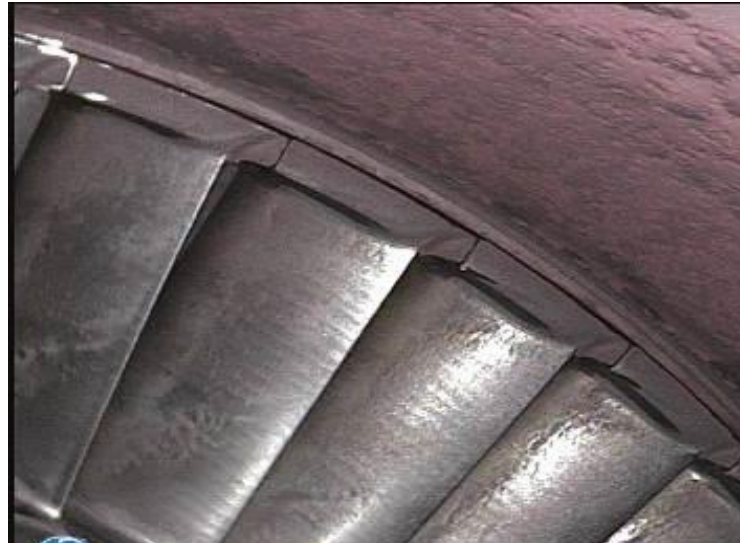
Stage without deposits

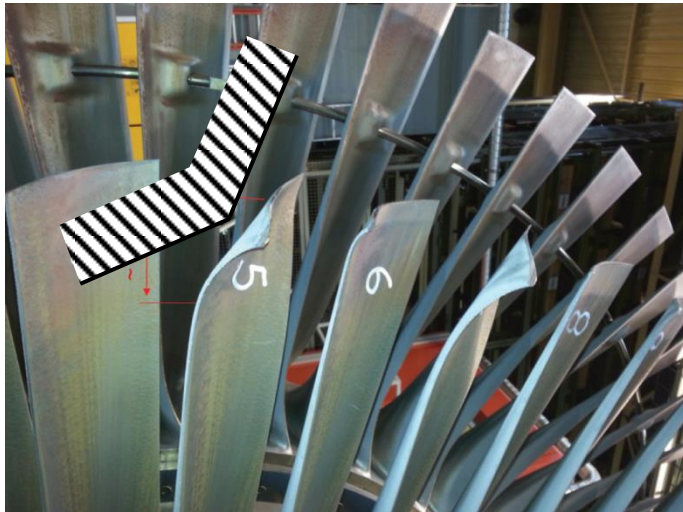
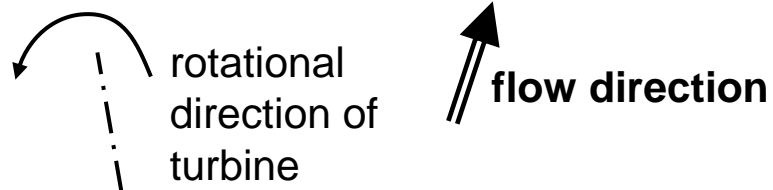
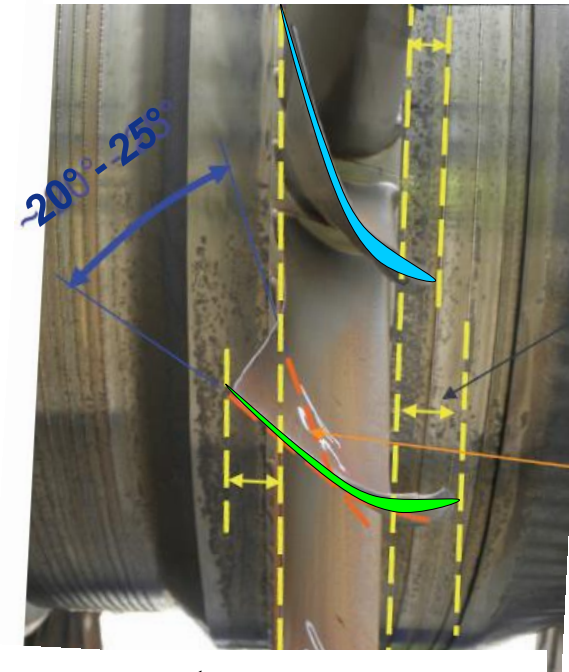
Bended and back-twisted blades (randomly distributed) at second final stage within low pressure turbine from hard contact with casing

White: un-damaged profile  
Green: back-twisted profile  
Blue: bended profile

Water / (cool) steam hammer on the blades

The last steam extraction within the turbine was not correctly drained (manually).

A daily started steam turbine must be equipped with automatically operated valves for drainage!

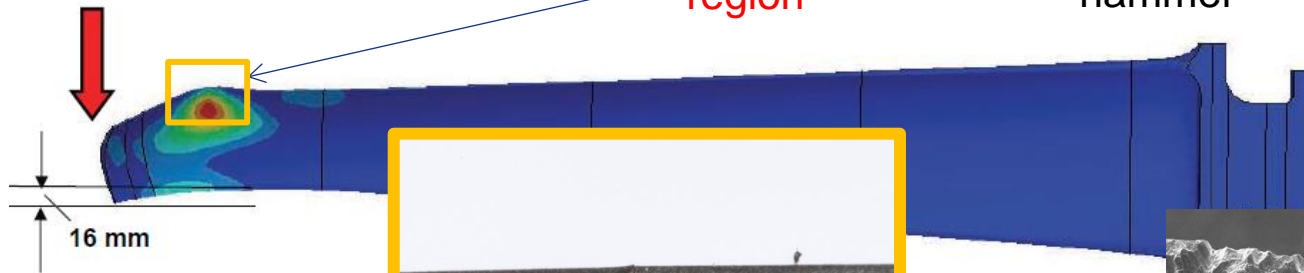
Most stressed region

FE analysis of a water hammer

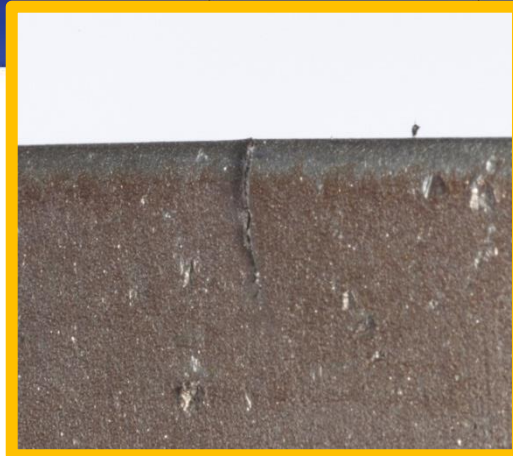
Crack found at most stressed region

Opened up crack shows only signs of forced fracture
