Allianz Center for Technology

80th Anniversary:
A Tradition of Risk
Expertise & Insight

A special release from
Allianz Global Corporate & Specialty

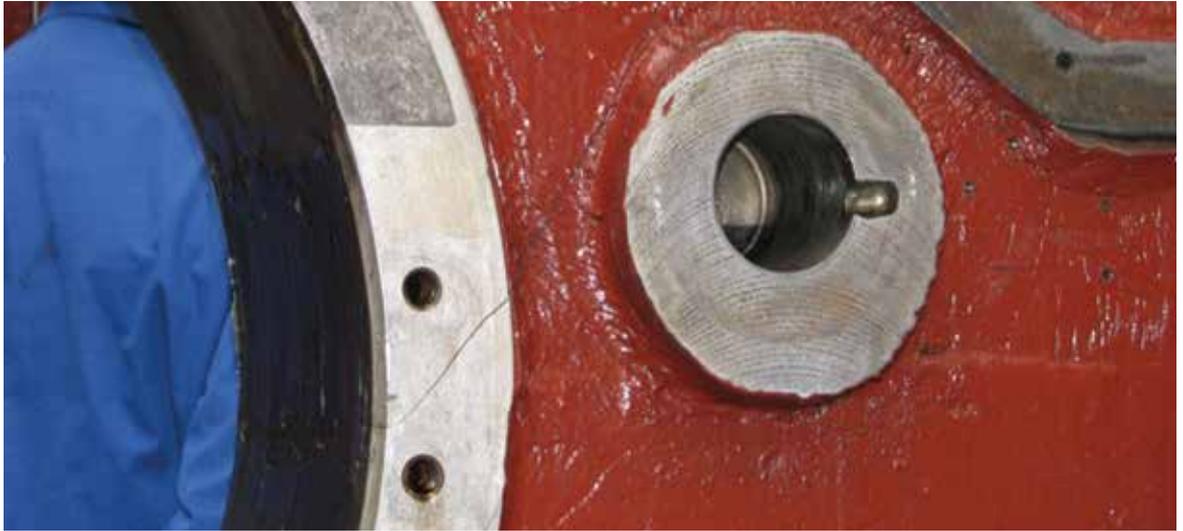
Figure 1: Crack in the frame of a progressive press

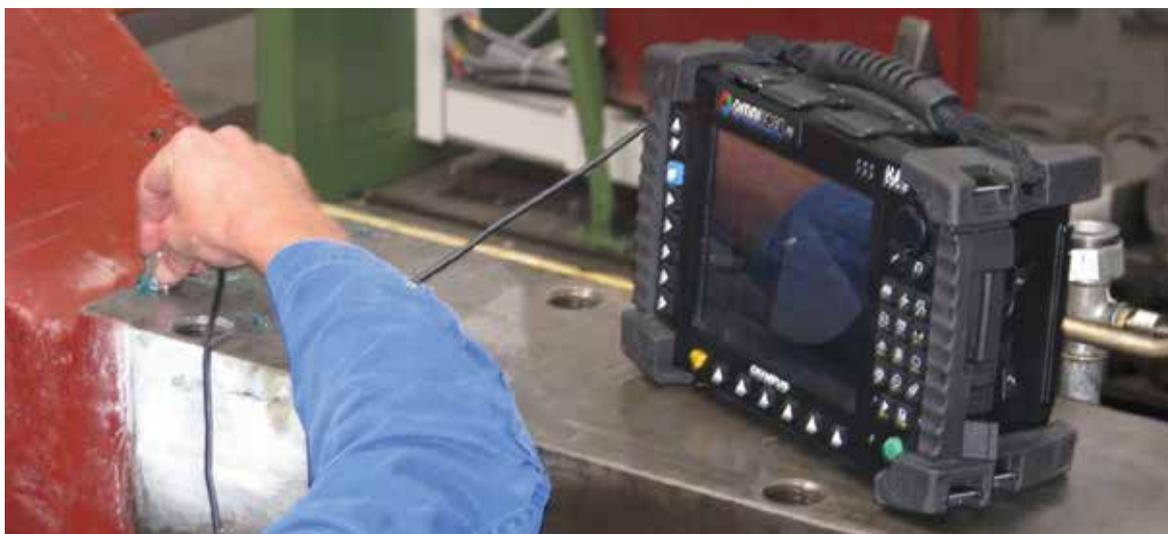
Figure 2: Phased Array Ultrasound Test (PAUT) of the area surrounding the crack

The examinations performed by AZT had to be conducted in such a way that repair work was not affected. As the technical documents for this press were no longer available from the client nor the manufacturer, a sample of the material was extracted from an area outside of the damaged zone and studied in detail. The material in the designated repair zone was checked with ultrasonic and magnetic particle inspections (Figure 2). No other deficiencies were found.

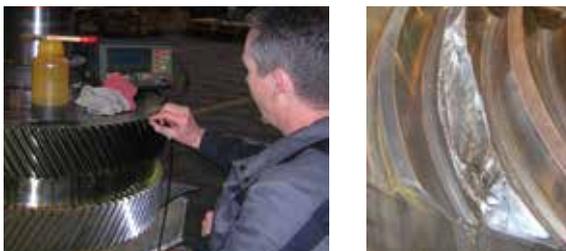
Figure 1 & 2: Tooth volume testing and gearing damages

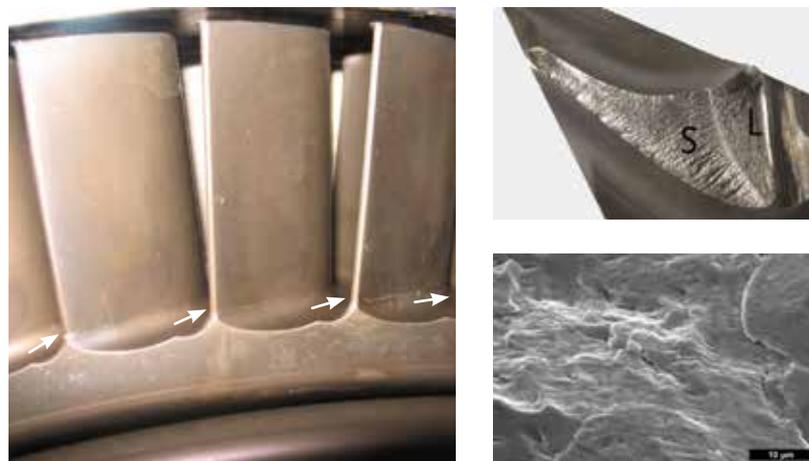
Figure 1
Left: Blade fractures (indicated by arrows) along edges.
Top-right: Exposed fracture (S = fatigue crack; L = laboratory crack).
Bottom-right: Fatigue striations shown enlarged 2,000 times.

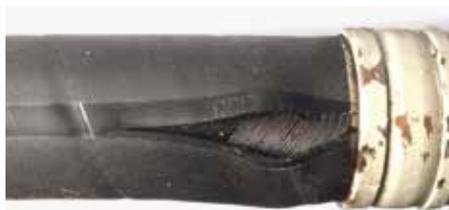
Image 1: Damaged hydraulic hose line

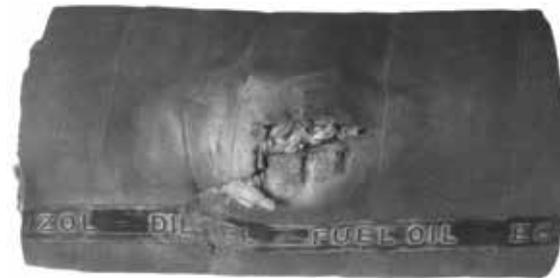
Image 4: The linear impression on the surface of the hose indicates a hose which was trapped or crushed in the area where the damage occurred.

The hose lines shown in Image 4 and 5 were used in different mobile construction machinery. The dent mark in Image 4, running diagonally to the hose axis, indicates that the hose was deformed by clamping and the steel netting mesh within the hose wall damaged. Normal operating pressure then caused the hose to break at this point. Usually, this kind of mechanical damage cannot be recognized after the hydraulic line has burst (image 5). This is where computed tomography (CT) scans can help (Image 6). This procedure allows deformations in the hose wall from clamping or crushing against the steel mesh to be detected and documented without damaging the hose. In both cases shown above, the installation failures led to environmental pollution from leaked hydraulic fluid.

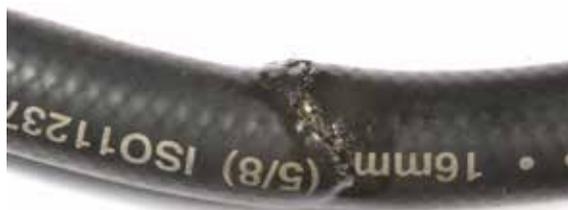
Image 5: Burst hydraulic hose line with a leak formation.

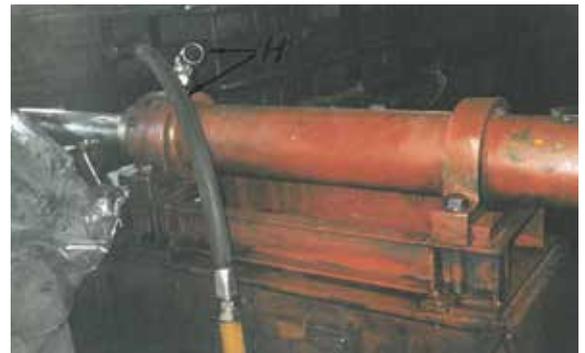
Image 7: Fire as a result of a torn hydraulic hose line (image: AZT).

In this case, the hydraulic hose on a production facility was torn off the fitting, as a result of normal operating pressure (Image 7). A nearby source of ignition then caused the hydraulic fluid that leaked out to catch fire, leading to business interruption and extensive refurbishment work in the workshop. The material investigation shows that the cause of the leak was excessive wear and tear and not conditional of manufacturing. The excessive wear and tear could have been prevented by regular monitoring of the hose and timely replacement.

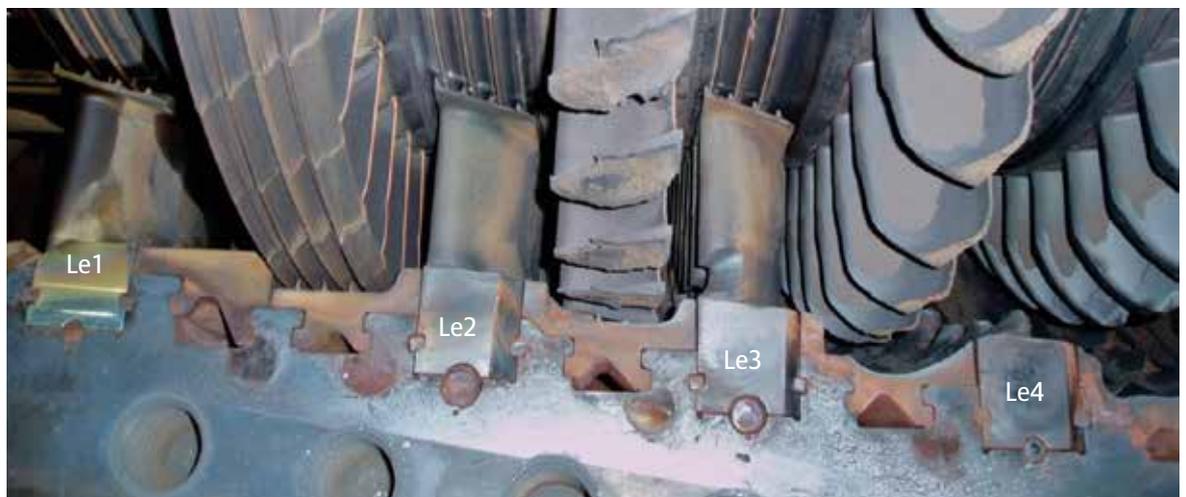
Figure 2: Damage pattern in the high-pressure turbine (image: AZT).

A tremendous temperature rise resulted in the blade rubbing off the distorted cover plates in the turbine's second blade row (to the right of Le2 in Figure 2). An iron fire was sparked from the frictional heat and spread as a result of the excess air throughout the high-pressure turbine, melting every row in a rotationally symmetric way. This steady process did not lead to an increase in the bearing vibrations over a longer period of time. Only after restarting the turbine did several weakened blades (as a result of the melting) break off, thus generating the vibrations and causing the shutdown of the turbine.

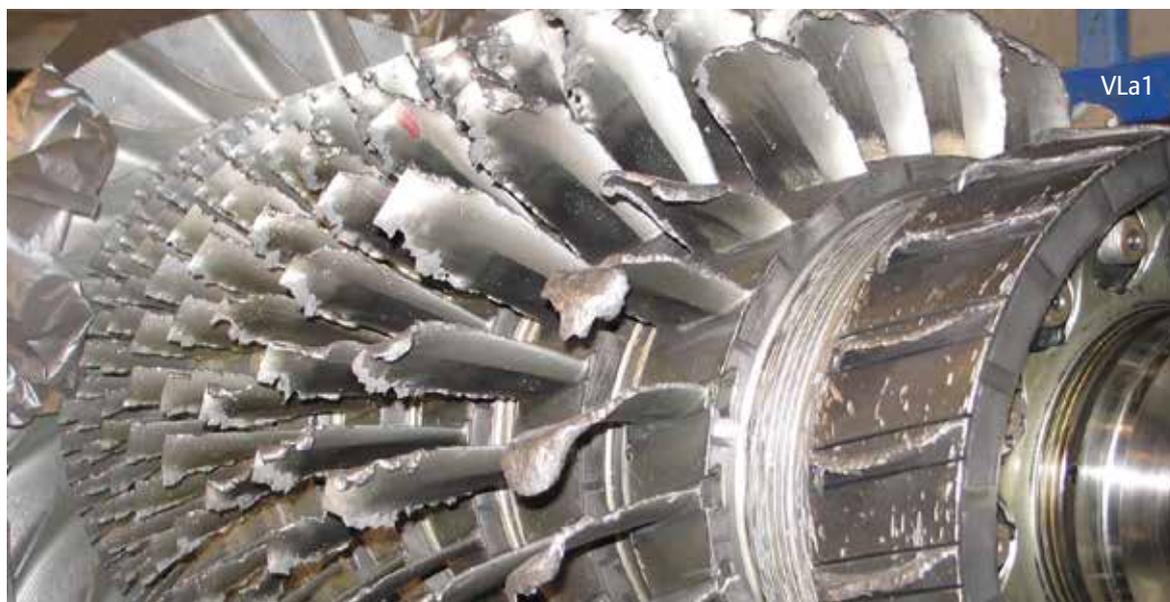
Figure 3: Compressor damage (image: AZT).

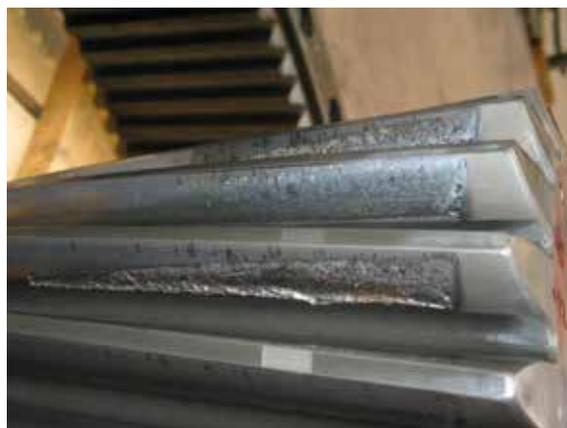
Figure 2: Sun pinion with tooth flank damages resulting from an irregular load distribution.

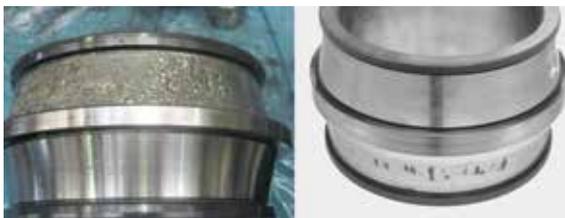
Figure 4 & 5: Damaged spherical roller bearings – planetary bearings (left) and damaged spherical roller bearings – rotor bearings (right).

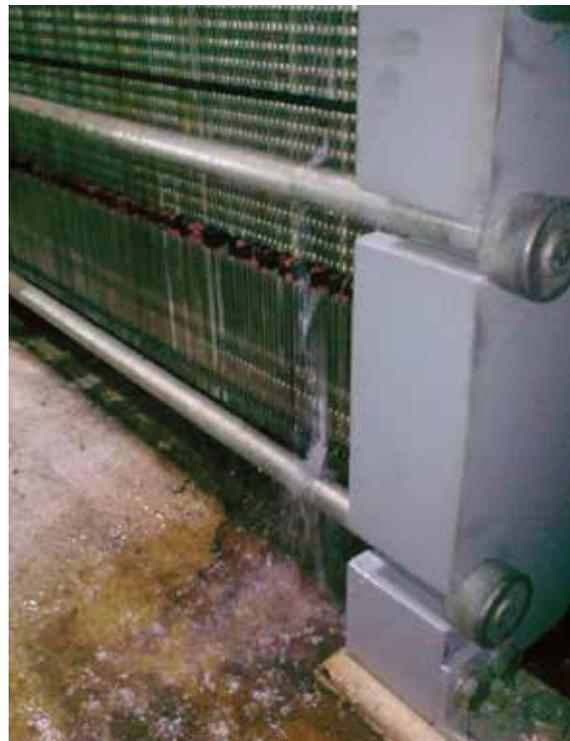
Figure 2: Partial view of the plate heat exchanger with a leak (Image: Siemens)

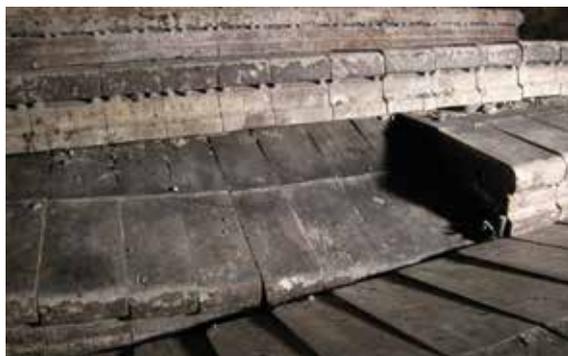
Figure 2: Damage of the grate as a result of overheating and corrosion

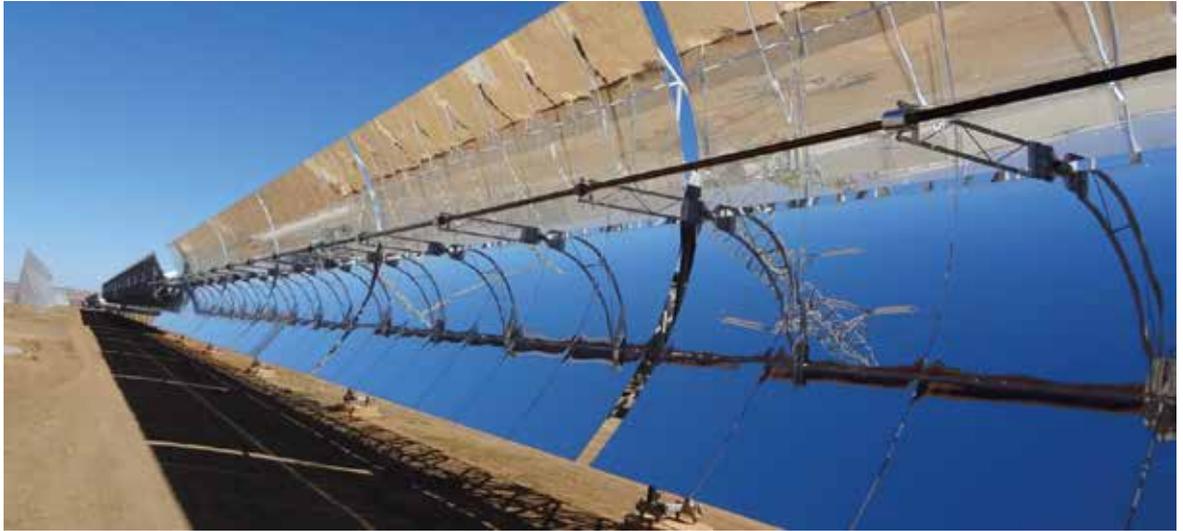
Figure 2: Parabolic mirrors with receiver pipes.

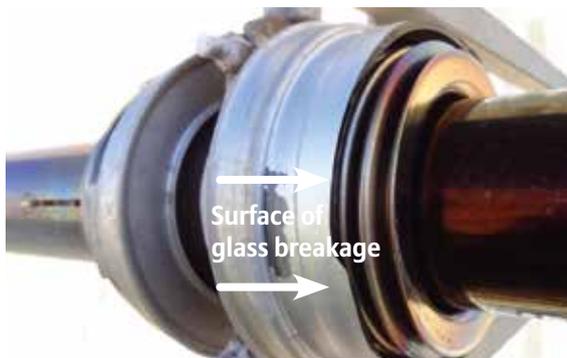
Figure 3: Typical glass breakage near the glass-to-metal seal.

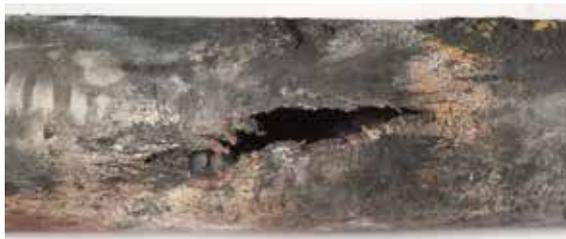
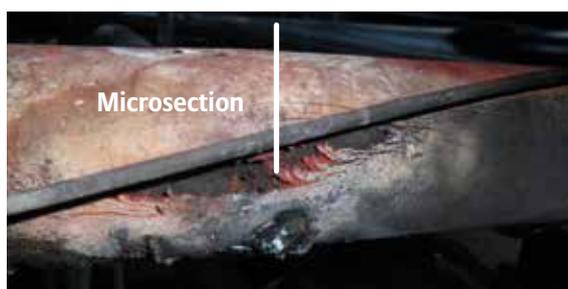
Figure 4 & 5: Split area (left) and trace heating line above the breakage area (right).
