# DAMAGE EXPERIENCE IN SOLAR THERMAL POWER PLANTS

Dr. Bernhard Persigehl  
Dresden / May 24<sup>th</sup>, 2019

Allianz Risk Consulting GmbH – Allianz Zentrum für Technik

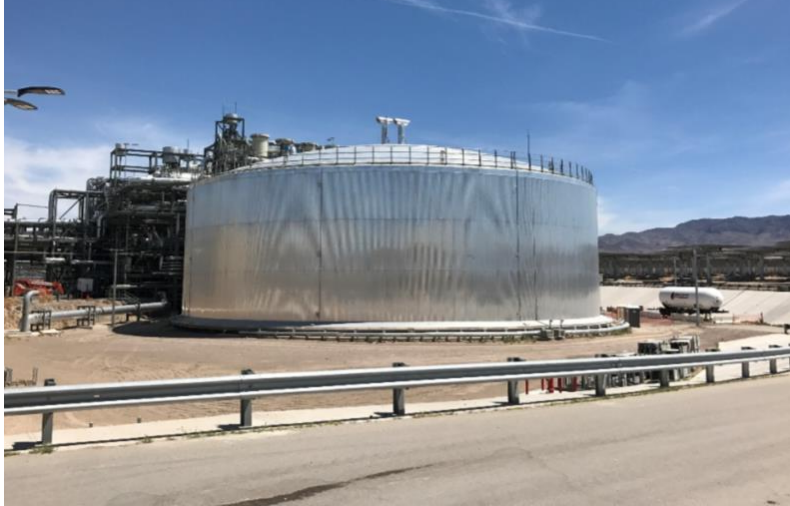
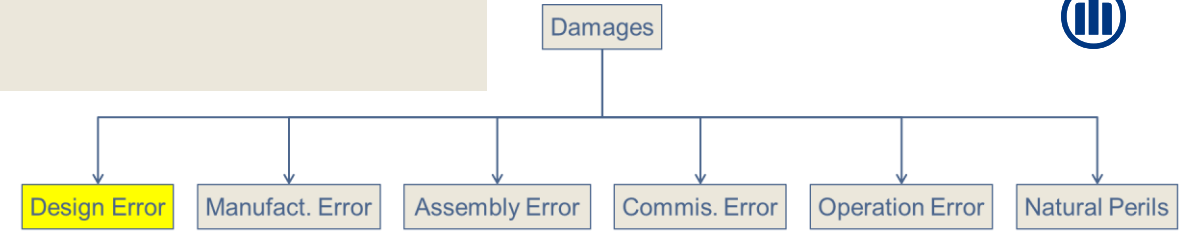
# SALT TANKS

- Cold salt immediately crystallizes
- Tank only accessible from the top
- Tank has to be completely drained
- 6 month standstill

- The salt inlet pipes were welded to the tank.
- Overdetermined
  - No degree of freedom for thermal growth
  - Crack initiation to the tank

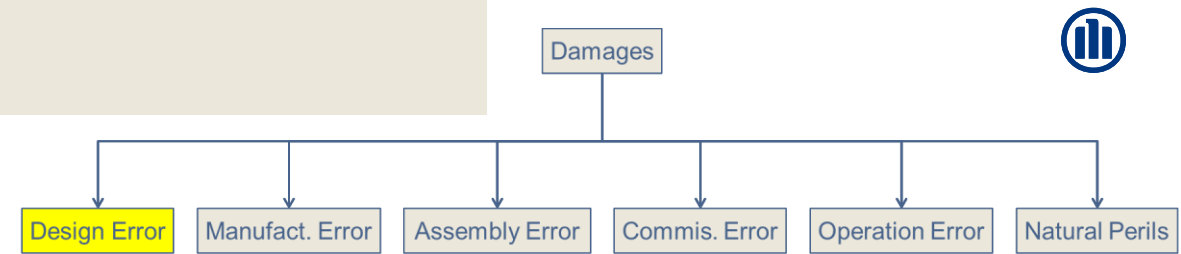
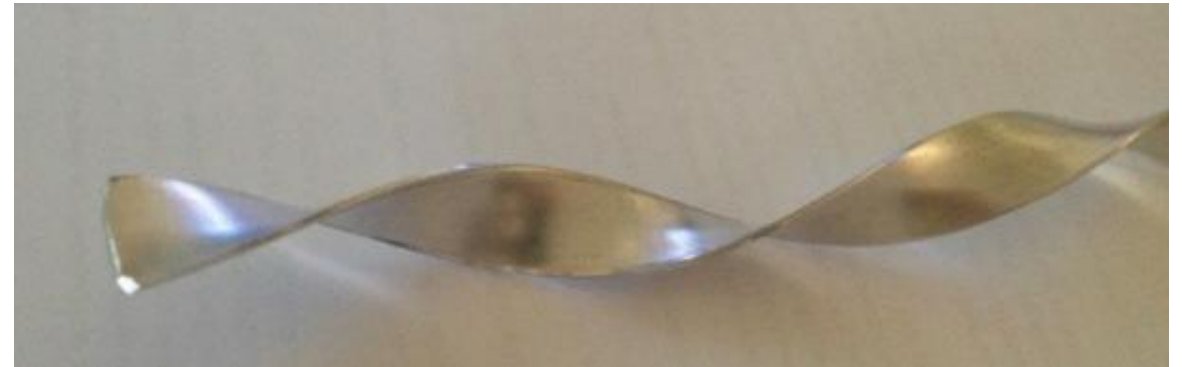
In the economizer, aluminum swirlers were implemented to improve the heat transfer.

„Due to problems with the water treatment the pH-value was too high leading to a rapid degradation (dissolution) of the aluminum swirlers. The system was cleaned and stainless steel swirlers were implemented.“

Residuals of Aluminum stayed in the system. They agglomerated in the affected stages, since the arising temperature of 300°C fits to a level change of the aluminum oxide.

There must not have been a problem with the pH-value during commissioning. It is generally not possible to adjust the pH-value correctly for aluminum and steel.

→ Design Issue

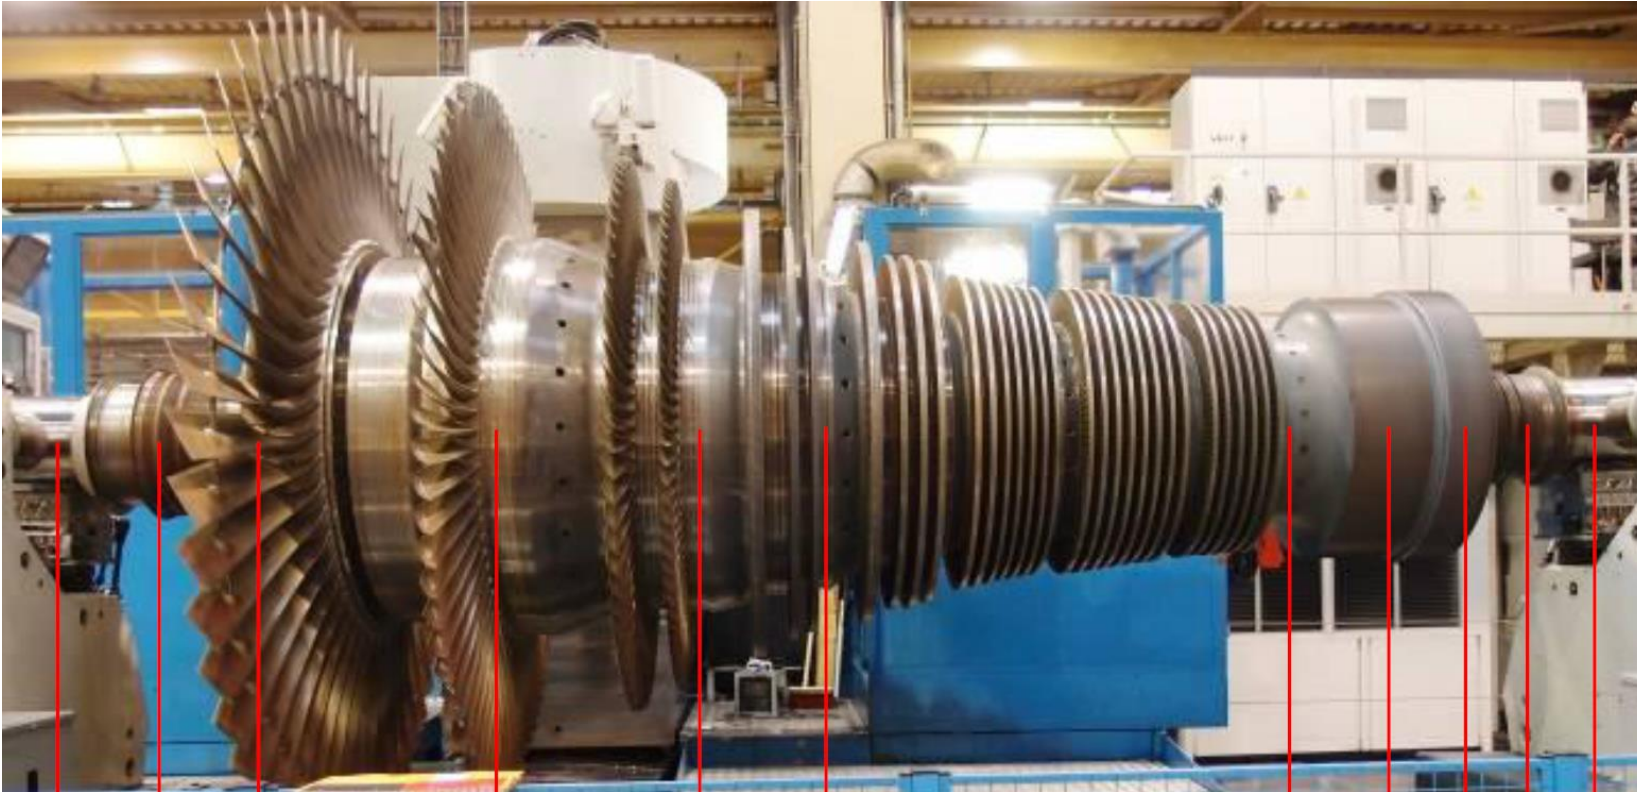
Low Pressure Turbine

Bended and back-twisted blades (randomly distributed) at second final stage within low pressure turbine from hard contact with casing
